# **Conservation of Bats in Attics**

## **A practical guide**

**BAT4MAN-HUSKROUA/1702/6.1/0021**

PUBLISHED BY **SLOVAK BAT CONSERVATION SOCIETY** © 2022

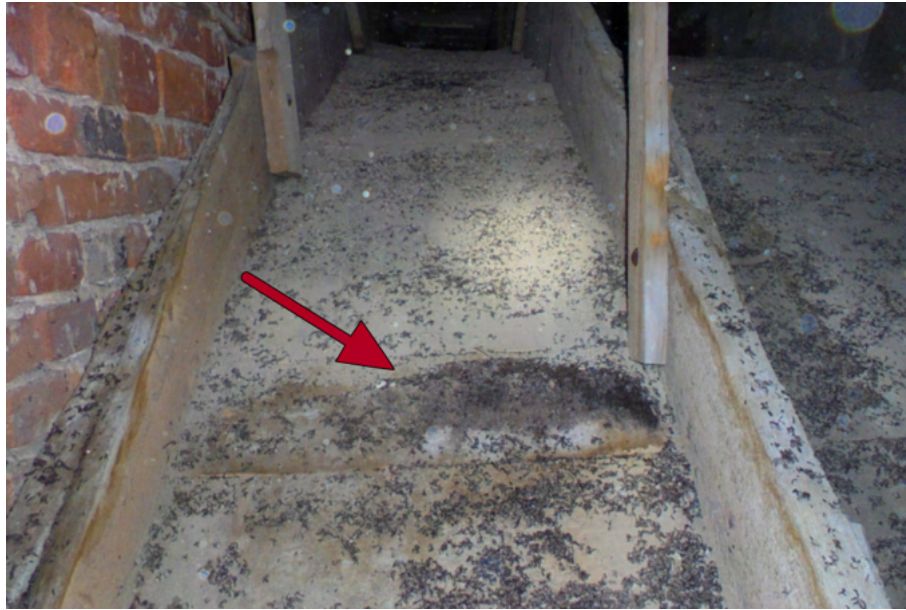
Fig. 1.1: A non-drying layer of droppings on the wooden vault of the church. The church's wooden vault is located under the attic floor. In this church, there is a large colony of the lesser horseshoe bat, about 200 females in size. Any measures are challenging in such a space because walking on the wooden vault is impossible. The only thing that can carry a person safely is a brick ledge along the edge of the wall and wooden ribs made of boards.

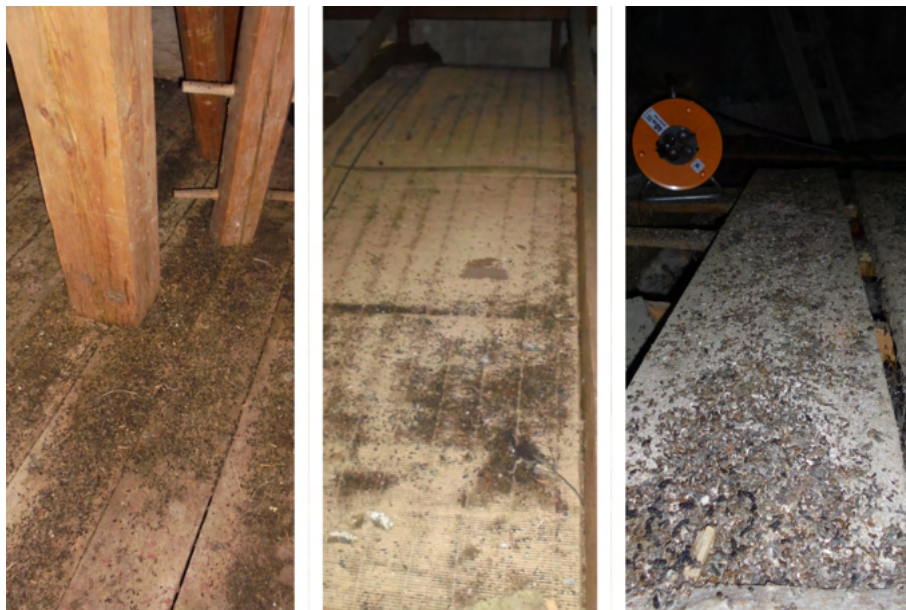
Fig. 1.2: Three different attics with the presence of the brown long-eared bat. Fresh droppings are visible on the right — shiny dark black, while older droppings from previous years are gray. In all cases, this is accumulated droppings over 5–10 years.

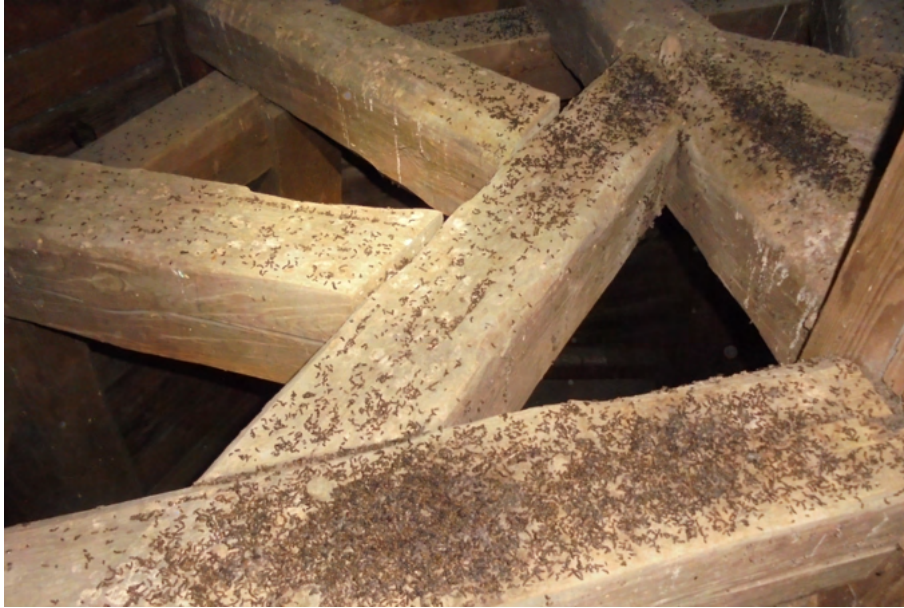
Fig. 1.3: A colony of the lesser horseshoe bat of about 80 females in the small attic of a church tower can produce relatively thick layers of guano, given the small space. In such cases — if space allows — we recommend either installing a platform or at least cleaning it annually (it is not necessary to protect the beams). This photo shows the amount created during a single season.

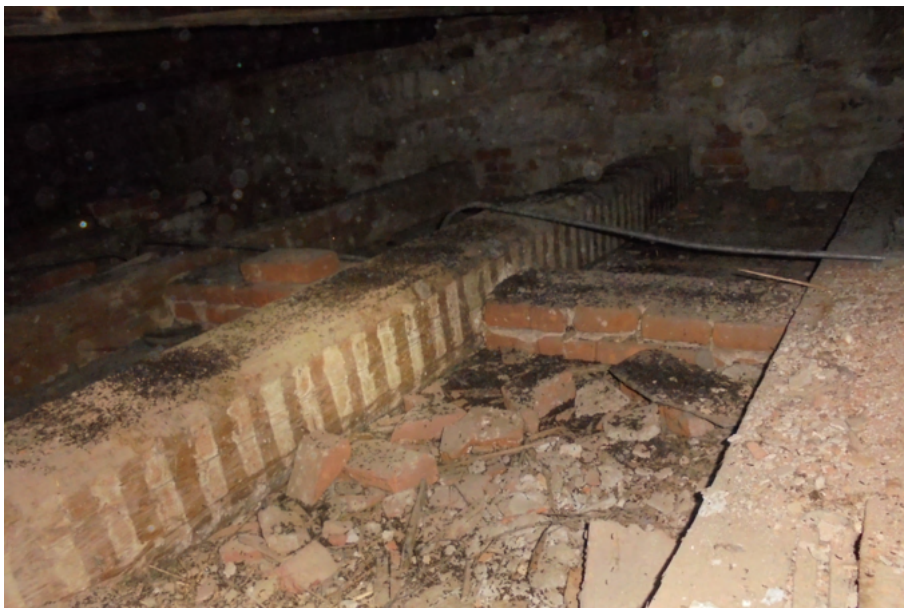
Fig. 1.4: The first cleaning is the most demanding — without exception. It is necessary to deal not only with various kinds of mess (e.g., construction debris) but also to be patient with a large amount of dust that clogs the filters of the vacuum cleaners. If the situation is similar to this photo, we recommend covering the surface with a tarp after removing the old droppings.

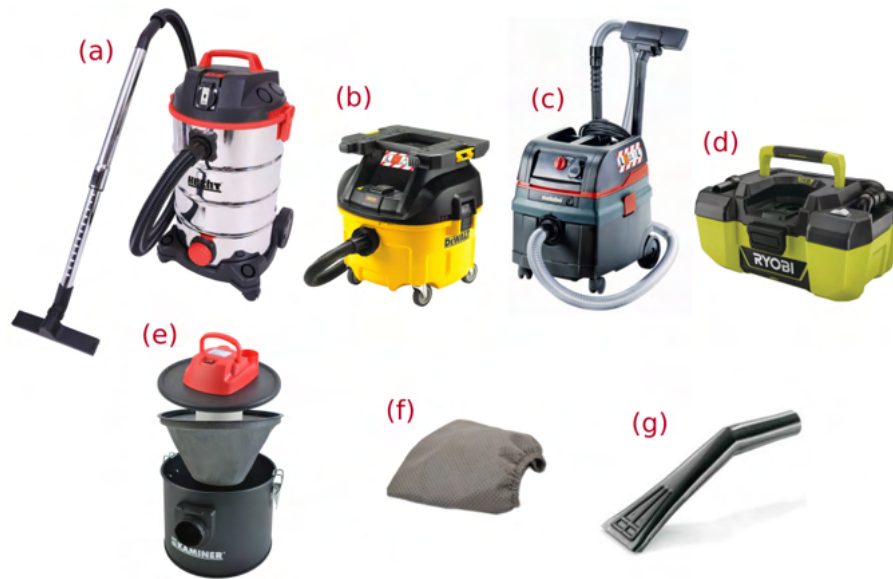
Fig. 1.5: Different types of vacuum cleaners and their accessories. Industrial models with a socket (a–c) are handy for connecting an additional lamp. The battery vacuum cleaner (d) is suitable for places without electricity. The fabric bag-stocking for the lamella paper filter near the engine can also be purchased as a spare part (e,f). KÄRCHER nozzle with a width of 90 mm (g). Most vacuum cleaners allow for the magnetic knocking of filters and store the dust in a plastic container, which can be quickly emptied.

Another alternative is vacuum cleaners resembling industrial ones, with an input power of 1400-1600 W and a metal container. Models with a fabric bag as part of the equipment, which is stretched over a lamella paper filter and serves as a fine pre-filtration (e.g., Hecht), have also proven themselves. A crevice nozzle is very useful. After trying many types, the KÄRCHER nozzle with a width of 90 mm turned out to be the best — it is ergonomically very well designed and significantly increases work productivity. In addition, its diameter is compatible with many vacuum cleaners of other brands (but be careful, with fireplace vacuum cleaners with a narrower hose diameter, it is necessary to make a reduction).

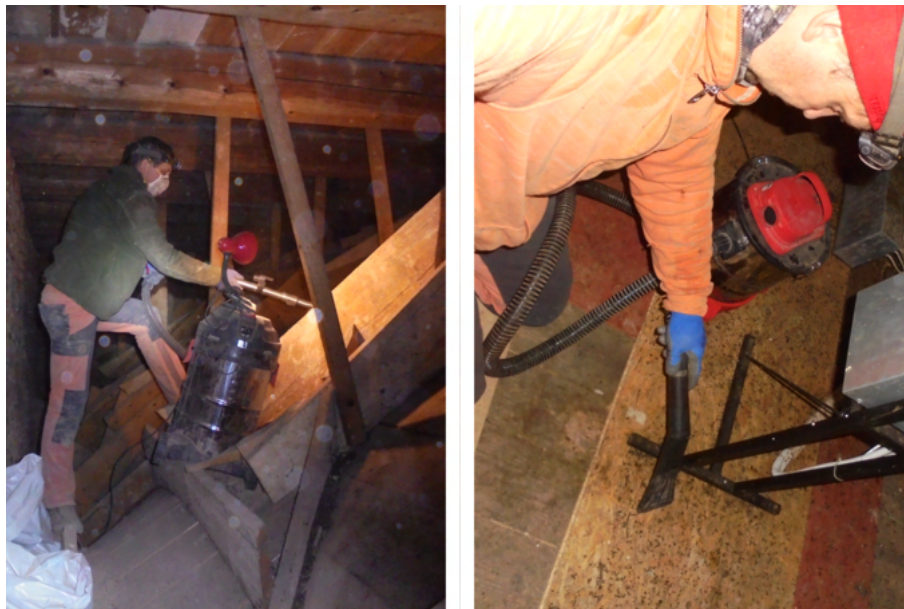
Fig. 1.6: *Demonstrations of guano cleaning up after bats. Vacuuming the droppings of the brown long-eared bat with a small fireplace vacuum cleaner (←). Vacuuming the droppings of the lesser horseshoe bat with a Hecht vacuum cleaner from the wooden vault of the church (→). You may notice the use of a clip light attached to the handle of the vacuum cleaner and powered from the outlet on the vacuum cleaner.*

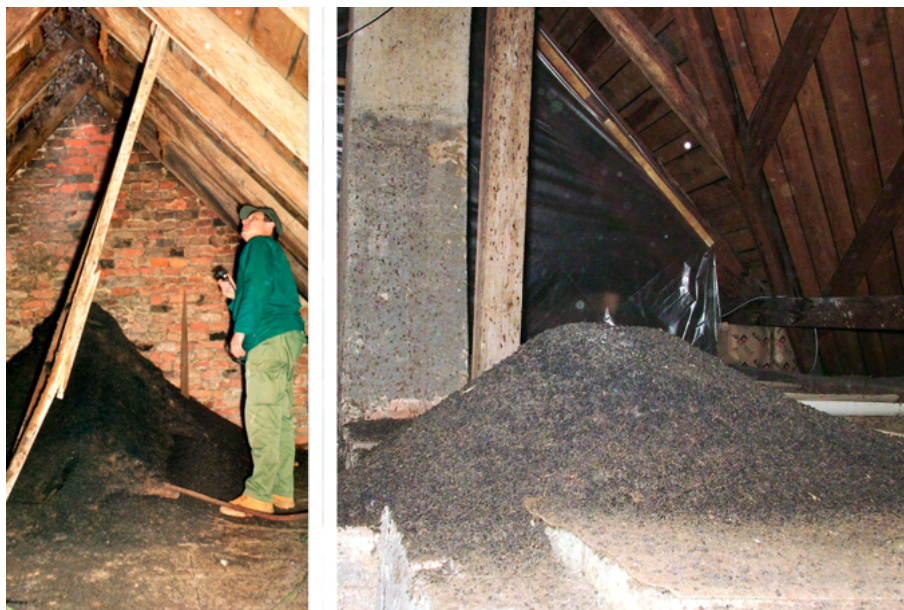
Fig. 2.1: *In attics with large colonies of large bat species, unmissable piles of guano are formed. The attic of the primary art school in České Dub. This pile consisted of 1.5 tons of guano (←). The pile in Vysoké Veselí — although smaller, was located in an apartment building where the tenants regularly cleaned the attic before our arrival. In the background, you can see the tarp that the tenants hung up to keep the bats from flying all over the attic space (→).*

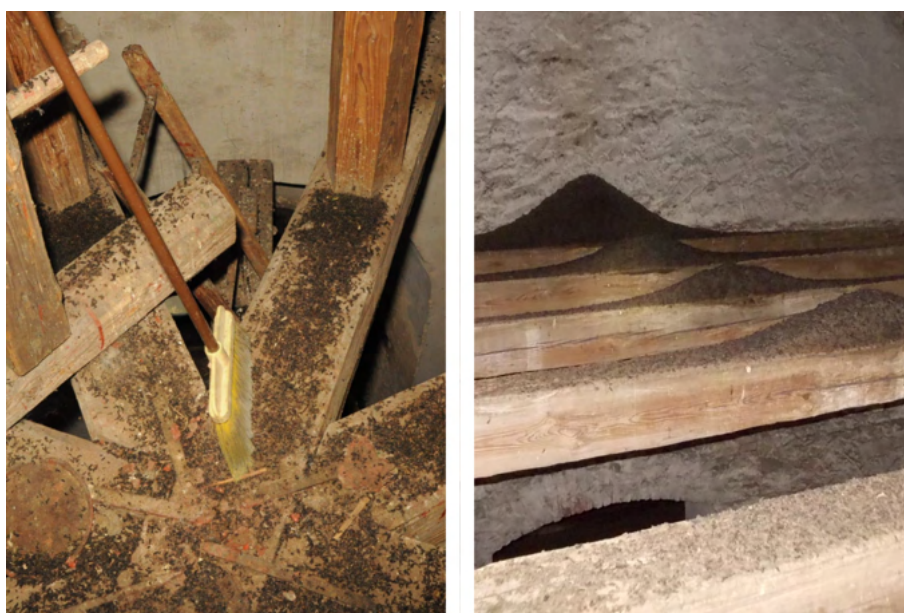
Fig. 2.2: *Bat guano dries well in thinner layers, but thicker layers retain moisture. If such a pile is on a wooden structure, it represents a significant problem. In some cases, regular sweeping by broom is sufficient (←). In others, it is necessary to cover the beams with protection (→) after removing the guano.*

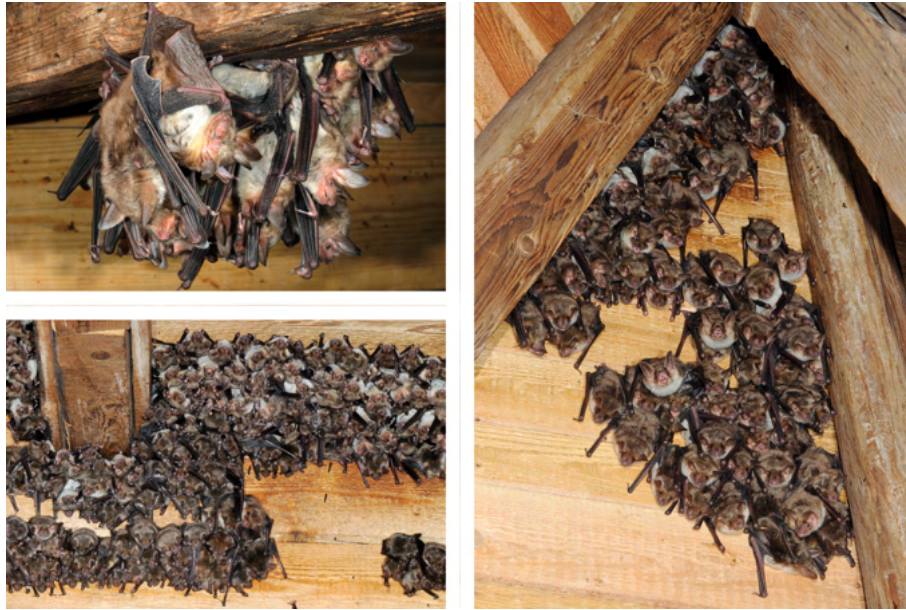
Fig. 2.3: Bats often use specific attic sites under the roof ridge ( $\leftarrow$ ) or near the beams ( $\rightarrow$ ). In church towers, we mostly found bats near the beams.

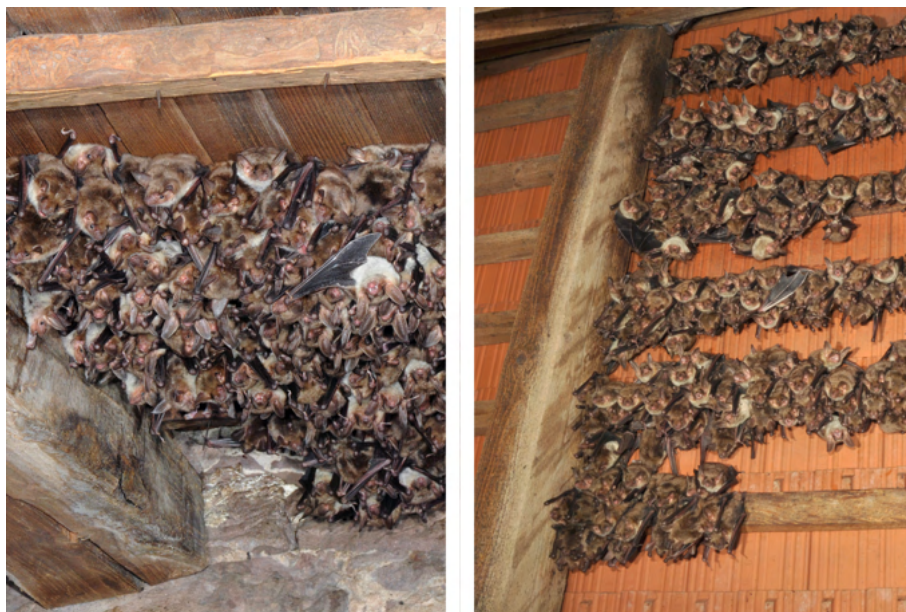
Fig. 2.4: In many churches, the roof sheathing is attached to the side of the wall — it is a very popular site for bats ( $\leftarrow$ ). More numerous colonies are often found hanged in rows and on a larger area from below on the roof sheathing ( $\rightarrow$ ).

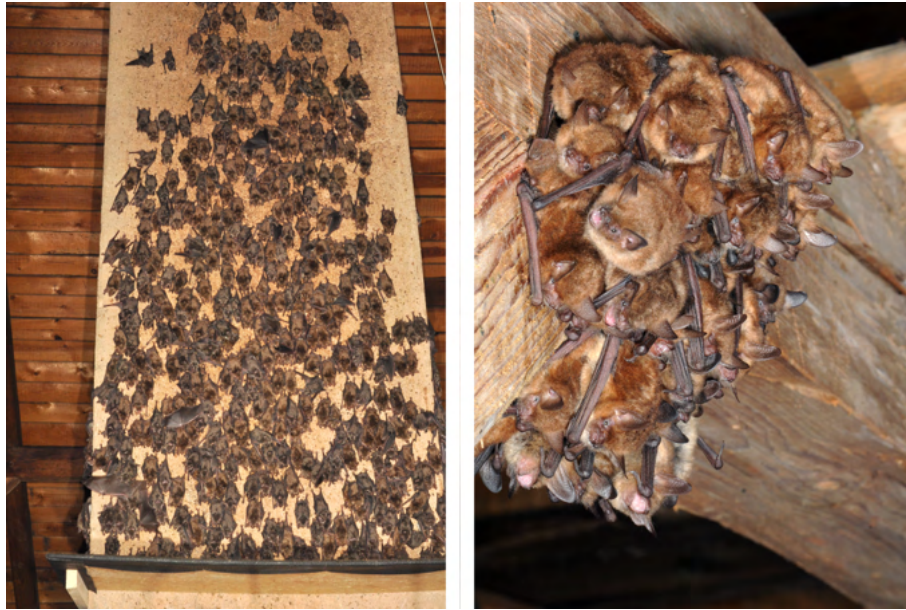
Fig. 2.5: *In the summer, the brick parts in the attics overheat the least. Bats cool down there on hot days. It is also the case with this group of the greater mouse-eared bat hanging from the chimney (←). Free hanging of bats on beams are probably the least common, but it is very characteristic of Geoffroy's bat (→).*

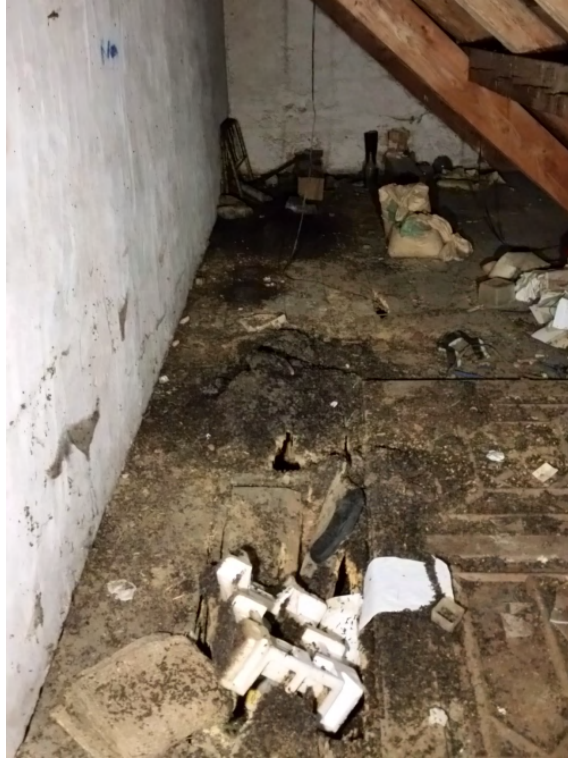
Fig. 3.1: An example of what the first cleaning can look like — there is often a lot of debris in the guano.

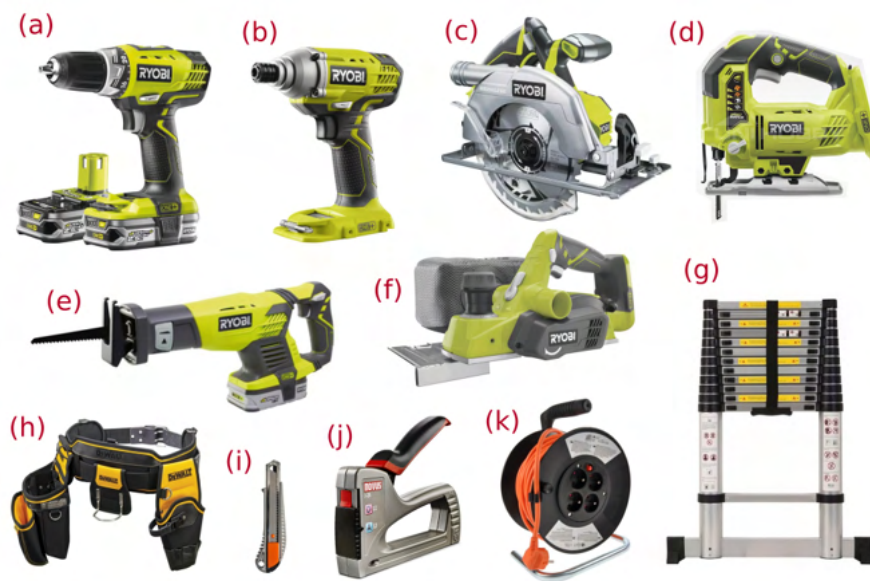
Fig. 3.5: *Necessary tools. A cordless drills are essential for pre-drilling and screwing (a,b). Different types of saws for adjusting the dimensions of boards — circular (c); straight line (d); tail (e). Bevel plane (f). Folding ladder for access to elevated places (g). Other small tools for greater work efficiency (h–k).*

- **Cordless drill:** The essential and most important tool. Suitable for screwing individual components and pre-drilling, which is necessary especially for laths so that they do not crack during screwing.

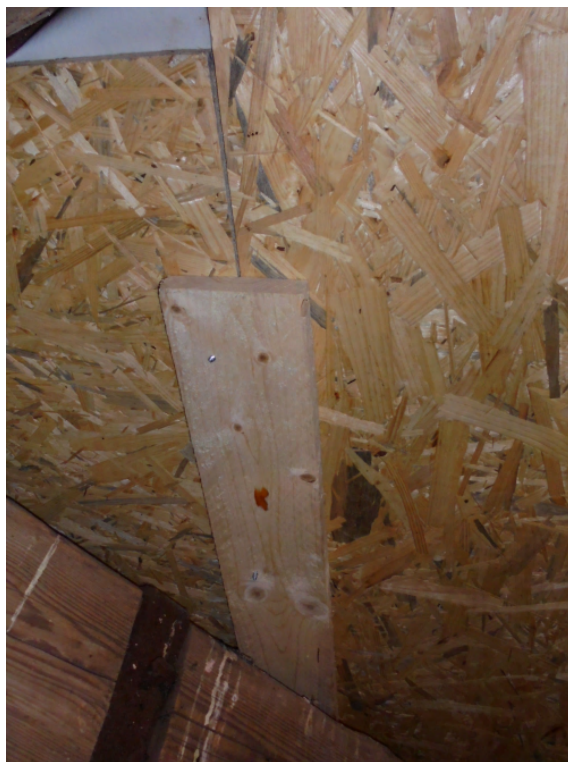
Fig. 3.7: Reinforcement strengthens the boards at the joint. It usually consists of a board placed under the platform at the point where the boards are joined.

If the platform must be raised, its beams can only be supported in the marginal parts of the vault in the place of the so-called backfill or on the heels of vault belts. Platforms and their supporting structures must not rest on the central parts of domes (vaults). The flexibility of the boards also allows us to copy various unevennesses caused by the beams or straining beams placed at different heights — the resulting surface of the platform is thus slightly wavy. However, even the flexibility of boards has its limits, and sometimes you cannot avoid supporting them on beams. If the boards are connected to each other in the space between the beams, then the reinforcement strengthens the joint.

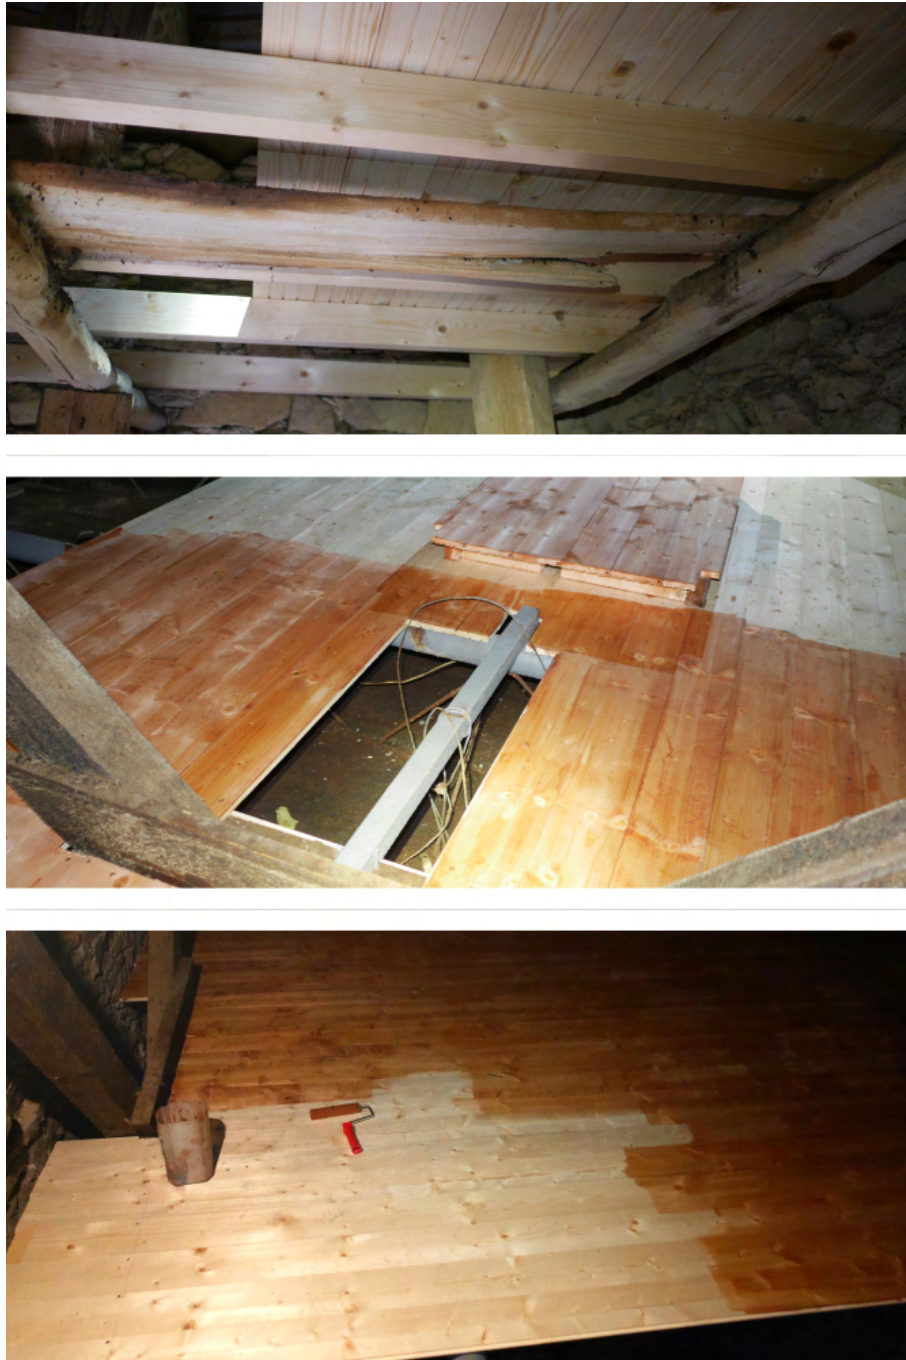
Fig. 3.8: *This platform was built in the church tower, where the truss and bells were heavily polluted by guano. Vertically placed prisms were used as a base on which solid spruce boards with tongue-and-groove were laid (↑). The removable part of the platform allows easy access to places where regular inspection or service work is required (centre). We do not need to cover floors made of solid boards with linoleum and foils — they can be treated with a protective surface coating that is harmless to health (↓).*

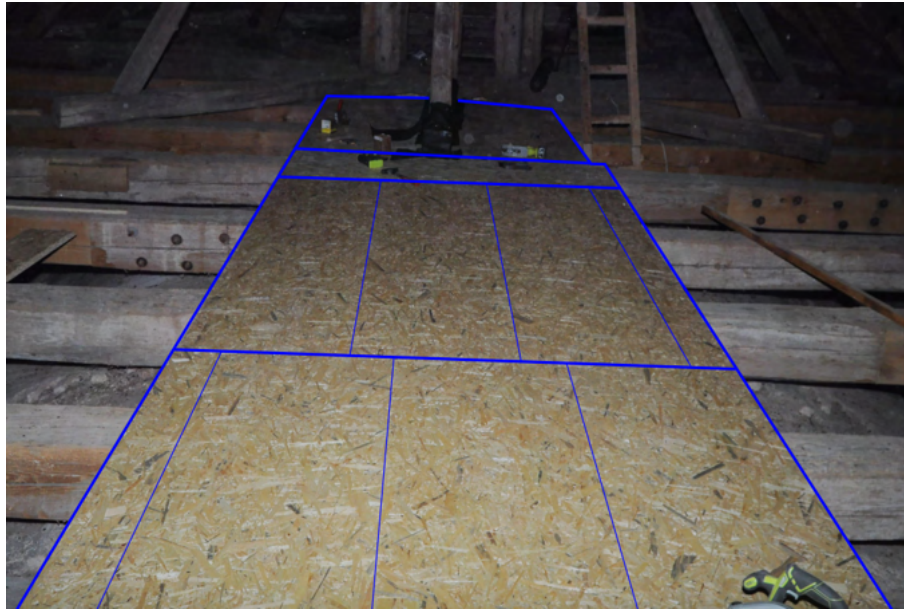
Fig. 3.9: The platform made of OSB panels laid on the horizontal beams in the church's attic. You can notice that three whole panels and one narrow strip are used for the width — it is placed once on the right and then on the left of the platform so that the individual joints of the boards do not connect. The panels' cut can only be on the edge of the platform.

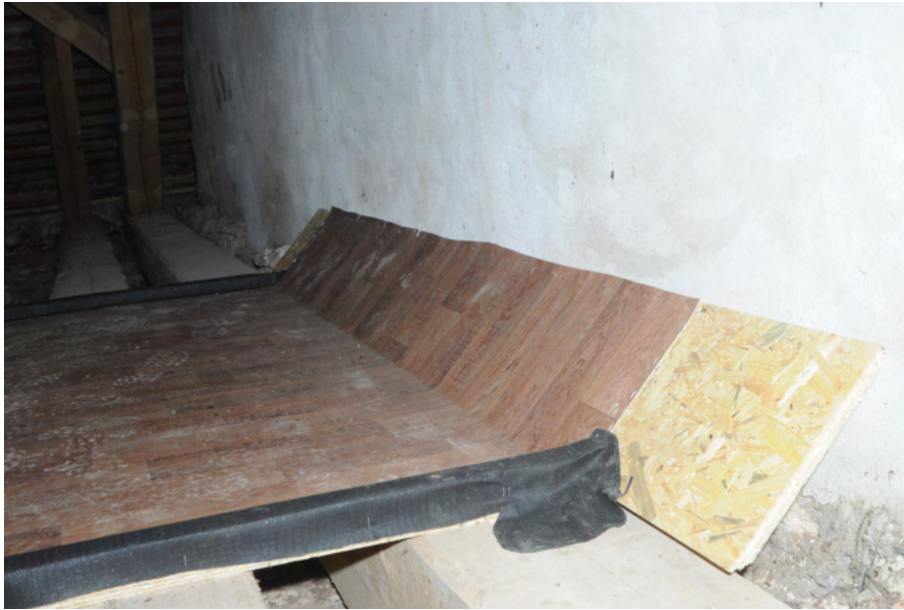
Fig. 3.11: *The platform covered with linoleum, whereas it's beginning near the wall is slanted. With such a bend, the linoleum must be carefully pressed into the corner before you attach it, so it does not tear later. A raised edge is already installed on the platform - however, we recommend to install edge later - on the top of the linoleum.*

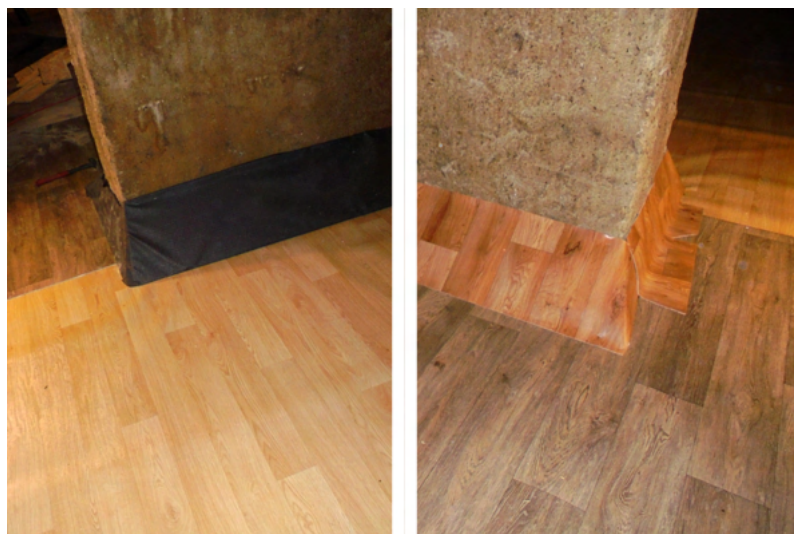
Fig. 3.14: *Diagonally laid boards protect chimney - they are around the entire chimney (←). The boards are covered with DTB foil, on which a strip of linoleum is still attached (→).*

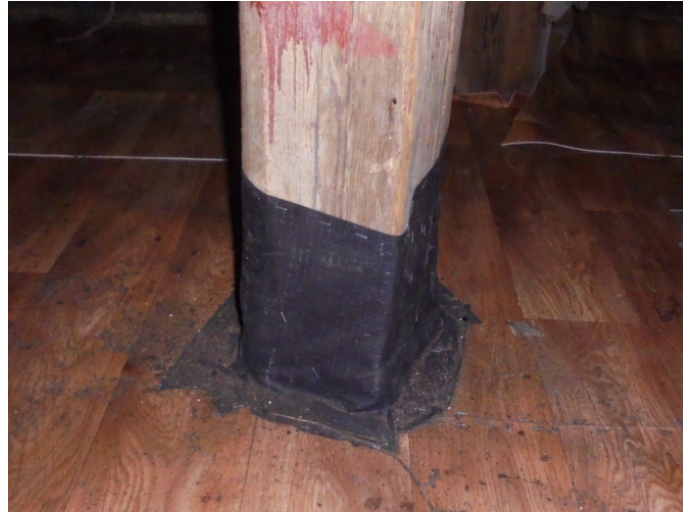
Fig. 3.15: *Protective collar made of DTB foil on the vertical beam passing through the platform.*

**Protection of vertical beams:** Sometimes you cannot avoid it, and one or more beams pass through the platform. It complicates the installation and the laying of linoleum. Protecting beams from the negative impact of droppings is also necessary. The best solution is to wrap the beam in its lower part near the platform using a strip of DTB foil in a collar. We fasten the strips with staples to the beam and to the platform. It is okay to layer several strips of DTB foil on top of each other.

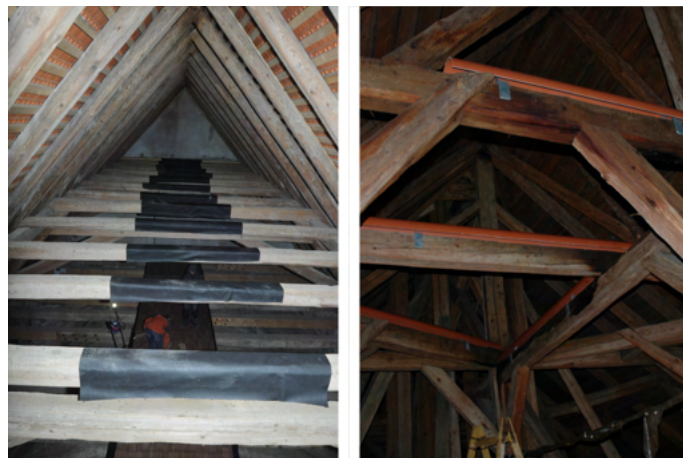
Fig. 3.16: *Protection of collar ties above the platform using a strip of DTB foil (←). Alternative solution with split PVC pipes (→).*

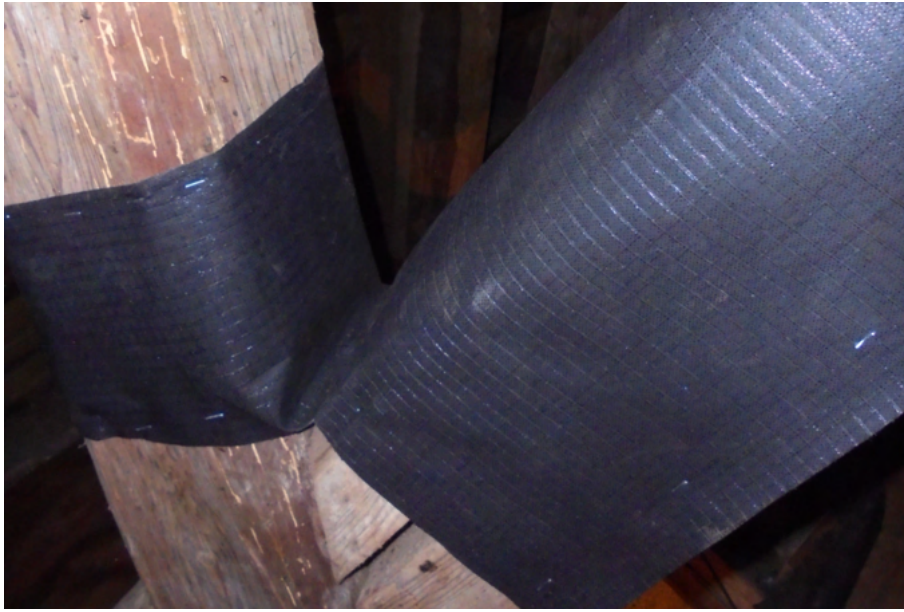
Fig. 3.17: *Even in this way, it is very easy to protect the groove of the beam using DTB foil.*

**Protection of the groove of beams and surfaces in the dome of the tower:** There are many attic components — in addition to those listed above — where bat droppings accumulate and must be protected. These are often different grooves of the beams or other elements, such as the internal surface of the baroque's tower dome, St. Andrew's cross, or rafters. DTB foil offers many solutions — with the help of cutting, bending and layering, you can achieve perfect truss protection. In addition, it is a vapour-permeable foil — it does not let moisture into the beam and, at the same time, allows it to dry. Thanks to the fibreglass grid, it is strong and durable.

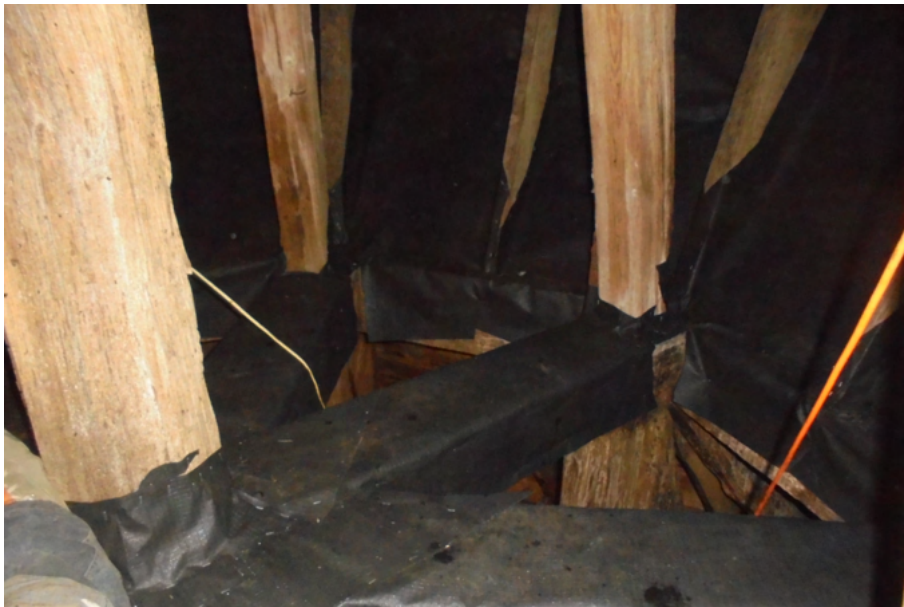
Fig. 3.18: *This is an example of using DTB foil to protect places in the tower where bat droppings fall. In addition to the horizontal beams of St. Andrew's cross, the lower part of the tower dome is also covered with this foil.*

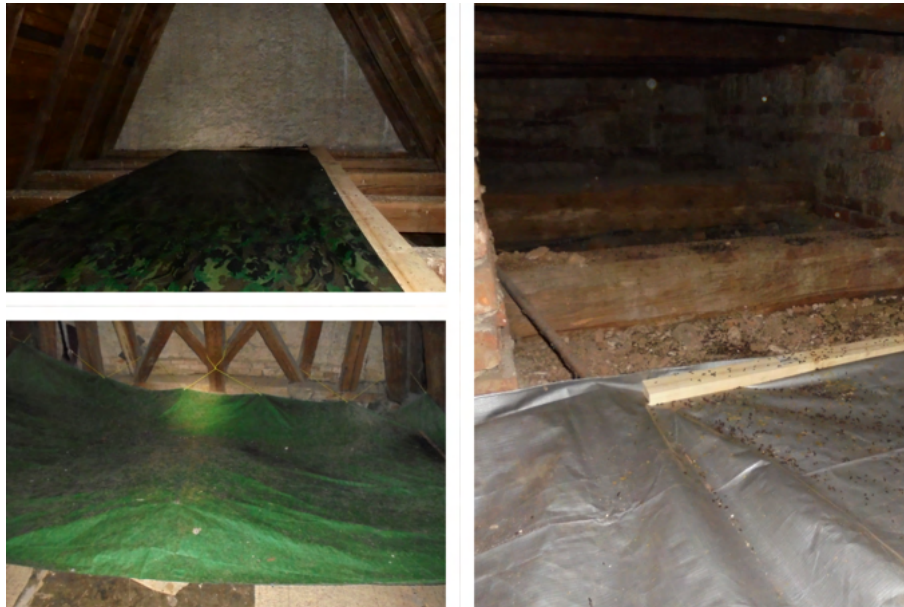
Fig. 3.19: *The tarpaulin is anchored with the help of prisms to the collar ties — here, it is sufficient to anchor only at the ends of the tarpaulin — along the tarpaulin is a footbridge made of boards to ensure access during cleaning.*

**Tarpaulins:** In places with a smaller amount of droppings, it is sufficient to stretch tarpaulins with eyelets. These tarps are strong enough, and the guano can be easily removed from them. Because they are placed in the darkness of the attic, they are not destroyed by UV radiation. In some cases, it is enough to solve the problem with bat droppings exclusively using tarpaulins. In some cases, we can combine stretched tarpaulins with platforms. However, it is necessary to be careful that they are not installed in poorly ventilated spaces where moisture can condense, or they can easily prevent the required air circulation in the attic. Tarpaulins can be purchased in various sizes, often 2×3 m, 2×8 m, 3×4 m — exceptionally even larger. We can use two different methods to anchor them — either we fasten them to the beams using screws and wooden battens (the lath placed from the upper side above the tarpaulin ensures that it does not tear), or we use the metal eyelets on its edge, through which we pull a cable (4-6 mm diameter) through which we secure the tarpaulin to by the surrounding beam so that it is taut. If we need an eye in the sheet in a place other than the original one from the manufacturer, we can complete the eye using a punch (10-12 mm) and a riveting set with spare eyes, which can be easily purchased.

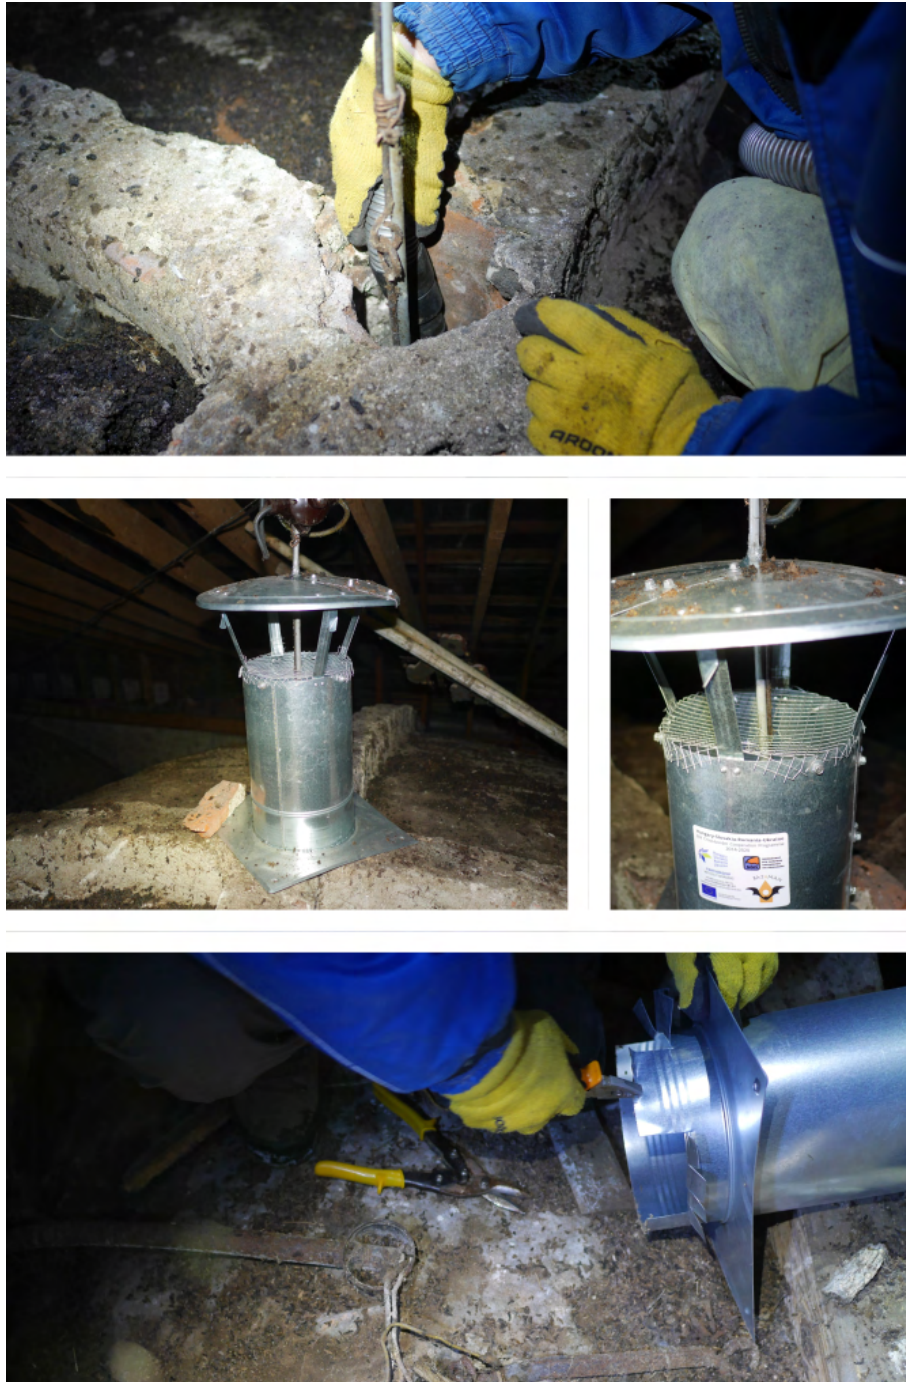
Fig. 4.1: *Before installing the canopy, thoroughly clean the opening with an industrial vacuum cleaner (↑). An example of covering an opening with a chimney cap. The pipe must have a thick covering mesh that protects the opening from the entry of bats (centre). We adjust the roof or cover plate on-site using a nailer's tool according to the local circumstances (↓).*

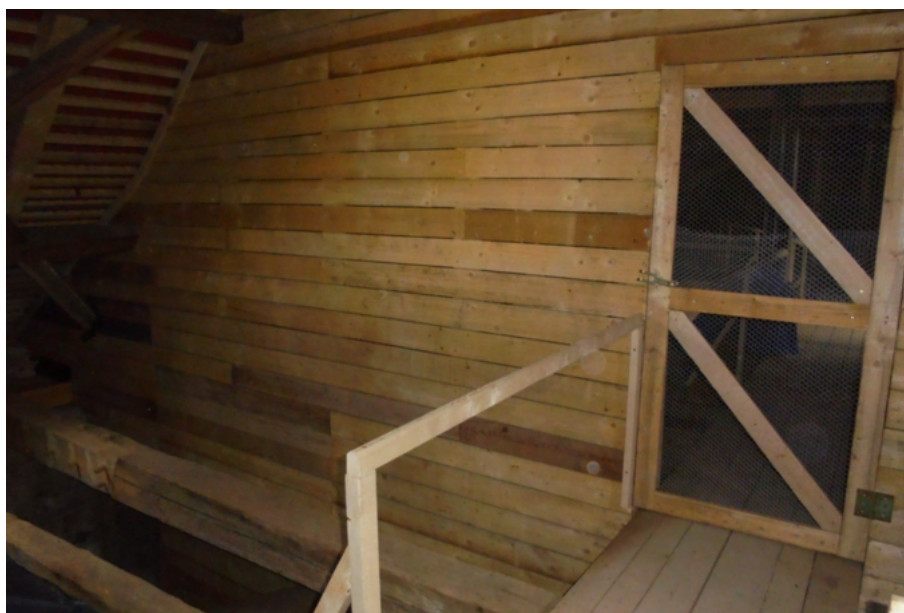
Fig. 4.2: *Partition of the attic space with a board wall. A mesh in the door and near the shield ensures natural air flow - the microclimate, therefore, remains unchanged.*

In cases where the house residents actively use the attic — for storage, drying clothes, etc. — it is possible to solve their coexistence with bats with a relatively simple construction that divides the attic into two parts, and only one part remains accessible to bats. This division can be made either with a solid wall made of boards or simply stretching a tarp. When placing this partition, several important rules must be taken into account. The partition must not create a barrier between the flight entrance and where bats often stay. After installing the partition, there should still be enough space so that it does not significantly affect the microclimate necessary for raising the young (consult the chiropterologist about the size of the space left). It is also essential to seal all the cracks in the partition wall — if bats find such a crack, they will use it!

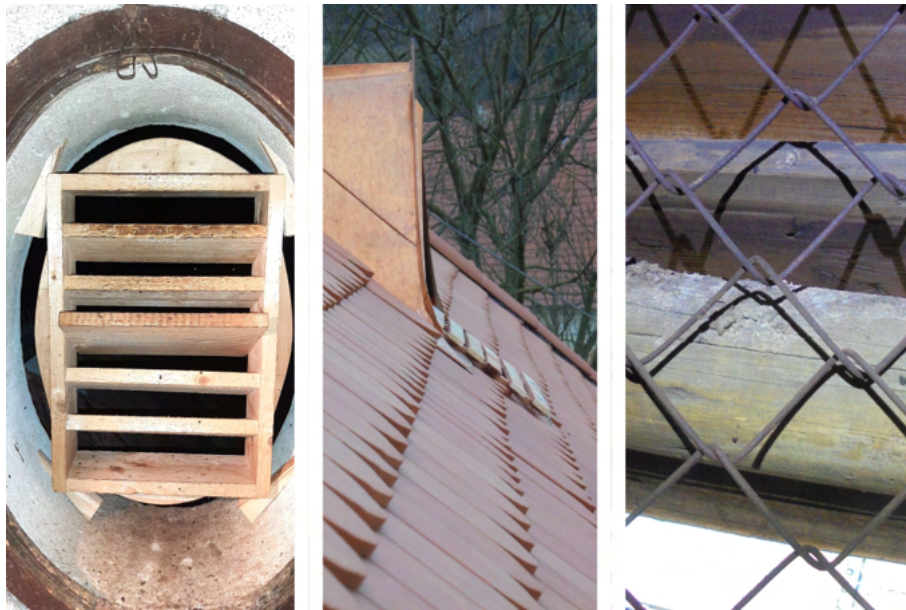
Fig. 4.3: *Blinds installed in the flight entrance prevent pigeons from entering. These blinds are fixed only with small wooden wedges — thanks to this, bats can also climb the wall around the blinds (←). A slatted grate located at the flight entrance of a large bat colony on a new glazed roof covering (centre). Rusted mesh does not cause any problems for bats when climbing (→).*

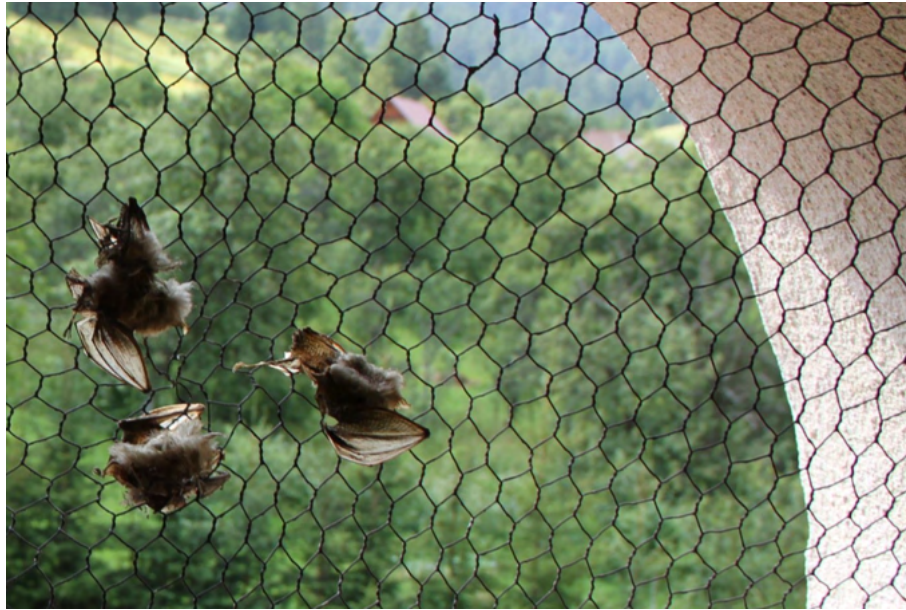
Fig. 4.4: A sad view from the church tower - an improperly closed entrance with rabbit mesh was fatal for the colony of the lesser horseshoe bats.

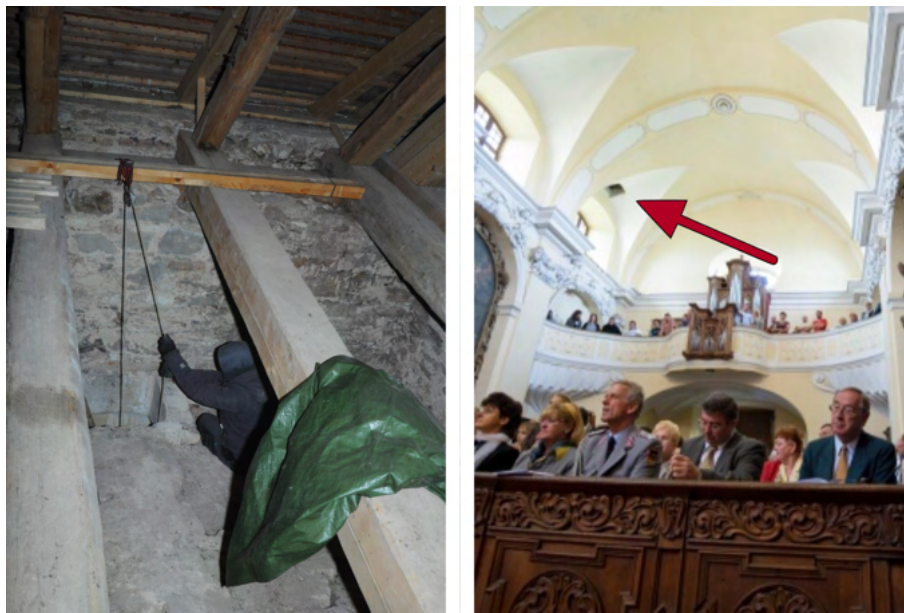
Fig. 6.1: Getting the material to the attic through the small opening in the vault above the choir was difficult. This was done with the help of a pulley and one person on the window sill, who guided the boards so that they passed diagonally through the opening in the vault.

( MILEŠOV; CZ ) In 2020, we were asked by the construction technician of the Litoměřice Vicariate to solve the problem of the newly formed colony of the greater mouse-eared bat (*Myotis myotis*) in the attic of the church of St. Anthony of Padua in Milešov. The platform is an example of the simplest and most common solution. It is placed in the middle of the attic under the ridge of the roof across the entire church and placed on the horizontal beams. The biggest challenge was getting the material into the attic, as the only access was a square opening in the church vault about 7 meters above the choir with a diagonal of 72 cm.

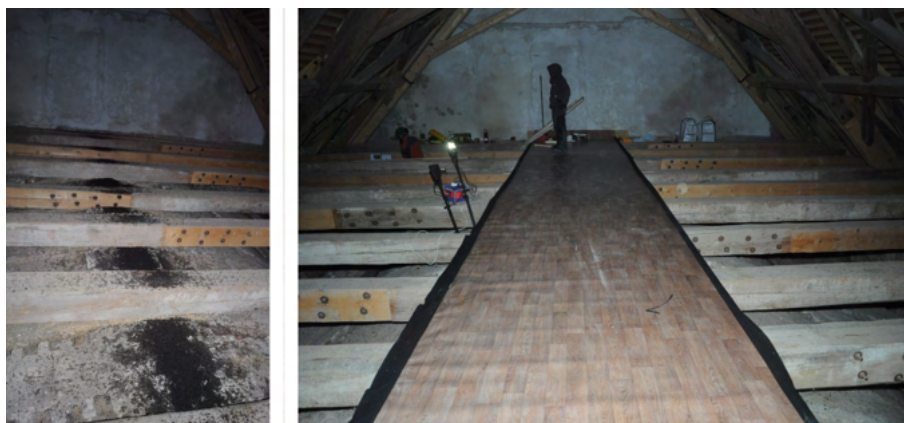
Fig. 6.2: Condition before (←) and after (→) installation of the platform. This measure was implemented very soon after bats occupied the attic. The number of bats and guano is small. The platform's capacity is also sufficient for a larger colony of bats. If the number of bats does not increase dramatically, cleaning is only necessary once every three years.

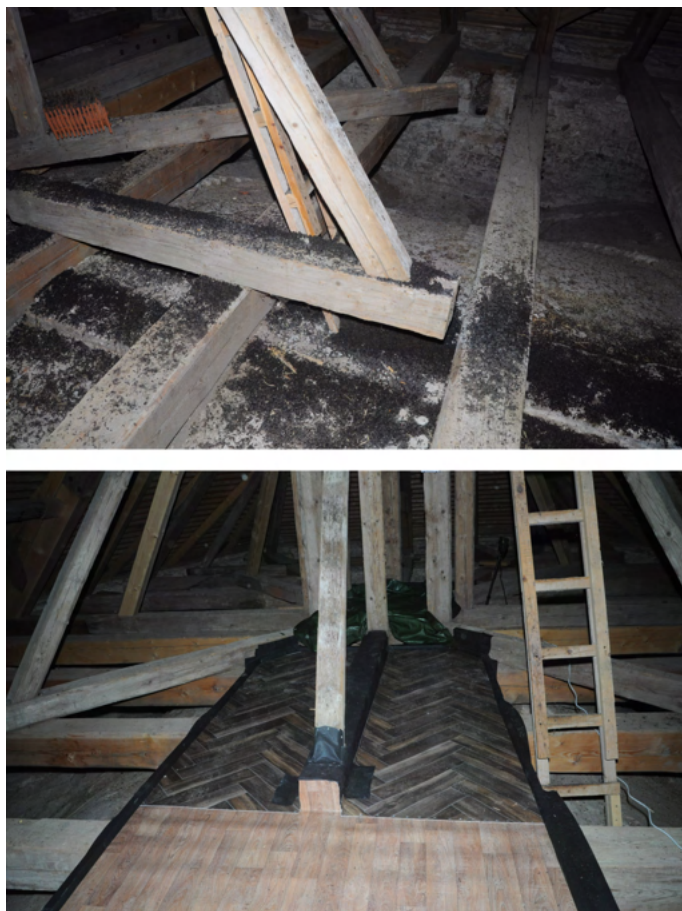
Fig. 6.3: The state before the implementation of measures around the support beam of the tower (↑). The finished platform — the central support beam and the raised edge of the platform are wrapped in DTB foil — the surface is protected by linoleum (↓).

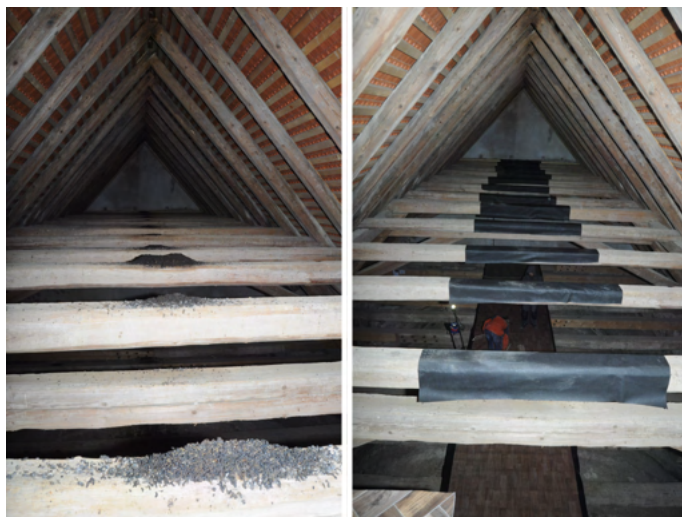
Fig. 6.4: Bats often hang on the rafters under the ridge, so a large amount of droppings is caught on the collar ties (←). Simple protection of the collar ties using a strip of DTB foil attached to the beams with a stapler (→).

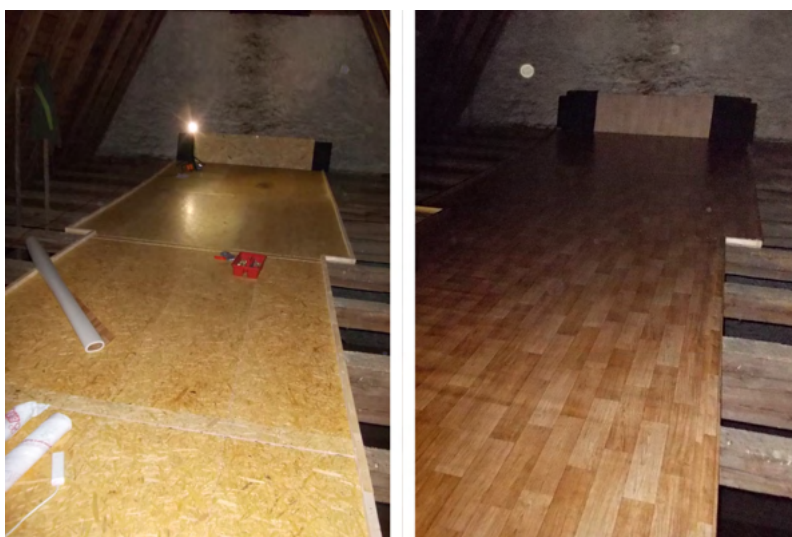
Fig. 6.5: A platform composed of OSB panels laid on beams. The raised edge was created before laying the linoleum (←). Finished platform with soft linoleum bent over a raised edge. The photo also shows the sloping end of the floor near the gable wall (→).

The platform was assembled from OSB panels 0.625×2.5m with a tongue-and-groove, and it narrows where fewer bats are above it. Its placing on the collar ties makes it possible to walk through the attic during regular use of the building and not wade through the guano. Thanks to this, both people and bats have more peace of mind.

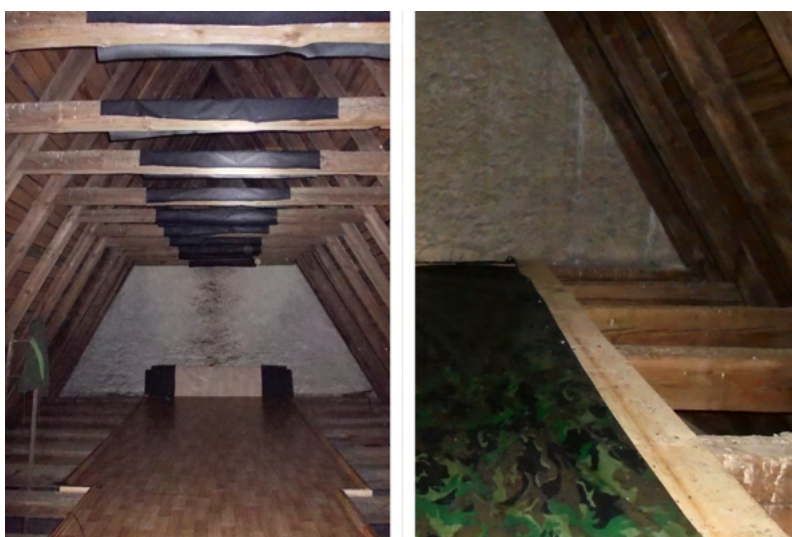
Fig. 6.6: Strips of protective foil on the collar ties (←). A stretched tarp (2×8 m) along which there is a boardwalk to clear the guano.
