# **Conservation of Bats in Attics**

## **A practical guide**

**BAT4MAN-HUSKROUA/1702/6.1/0021**

PUBLISHED BY **SLOVAK BAT CONSERVATION SOCIETY** © 2022

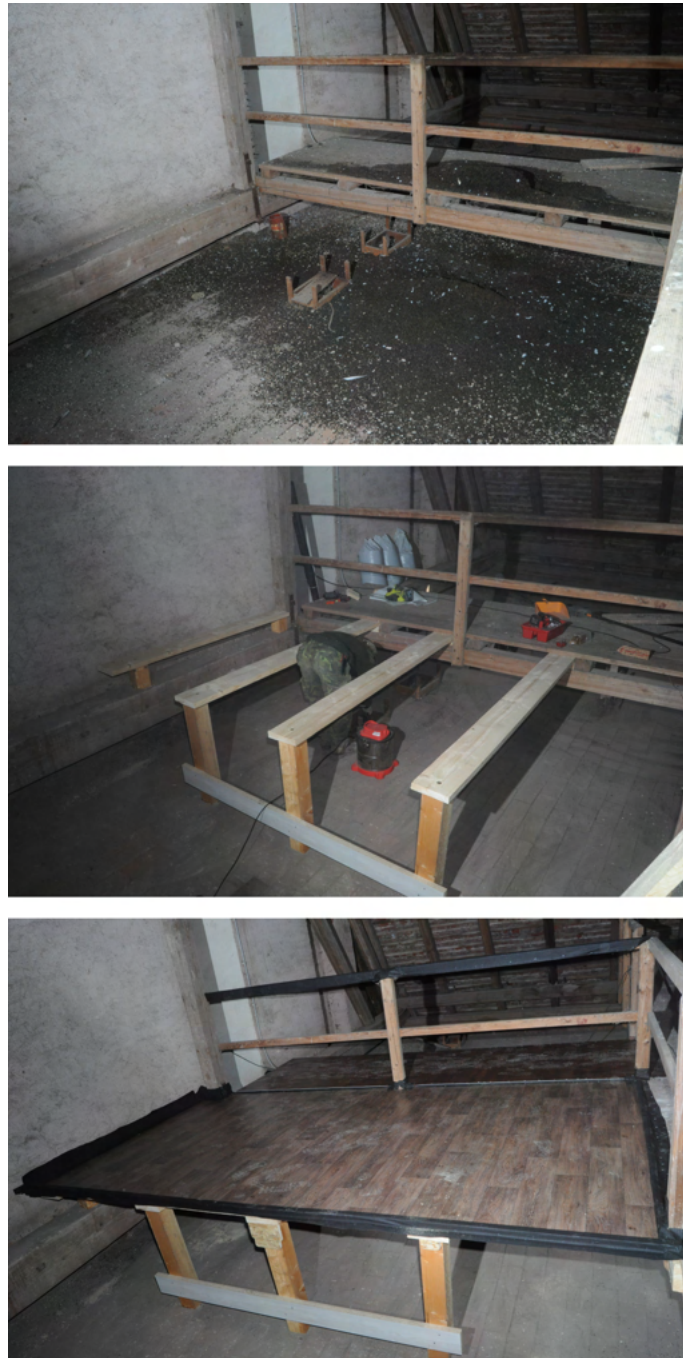
Fig. 6.7: Original state. Guano is on the floor, the catwalk, and the vents (↑). The support structure for the platform is connected to the footbridge. On one side, it is built on uprights (centre). A strip of DTB foil protects the railing. There is a slight height difference between the platform and the technical bridge, which is covered by a strip of DTB foil. (↓).

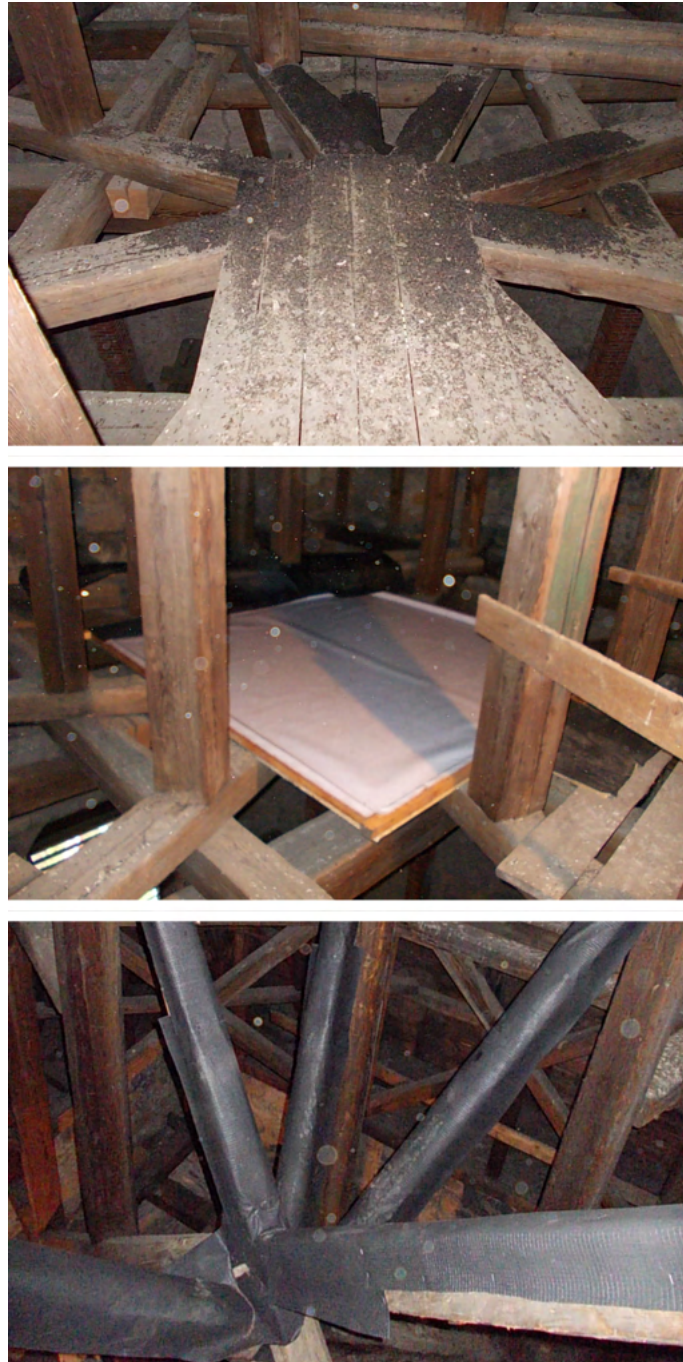
Fig. 6.8: Original state (↑). A simple platform covered with white linoleum catches most of the droppings (centre). Above the platform is a tangle of beams, which had to be protected by strips of DTB foil against guano (↓).

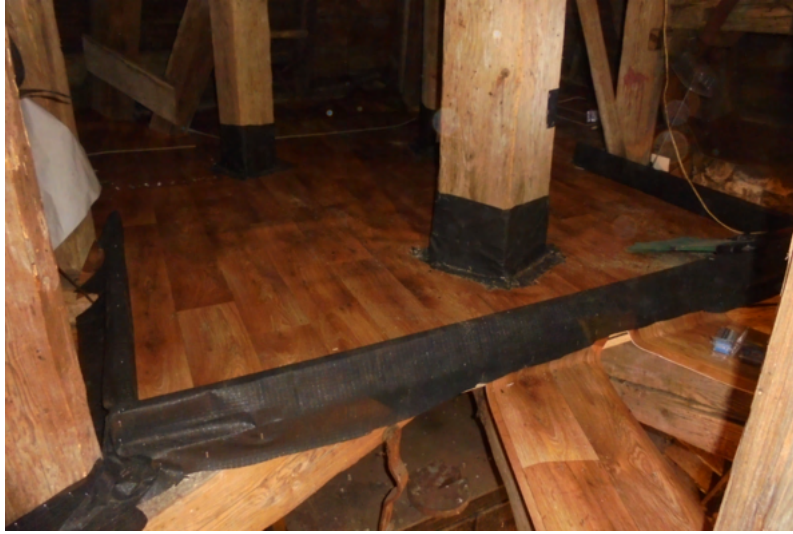
Fig. 6.10: *The platform above the clock has a 10 cm wide edge. After the first season, it turned out that the height of the platform edge was correctly estimated. The vertical beams passing through the platform also have a protective collar.*

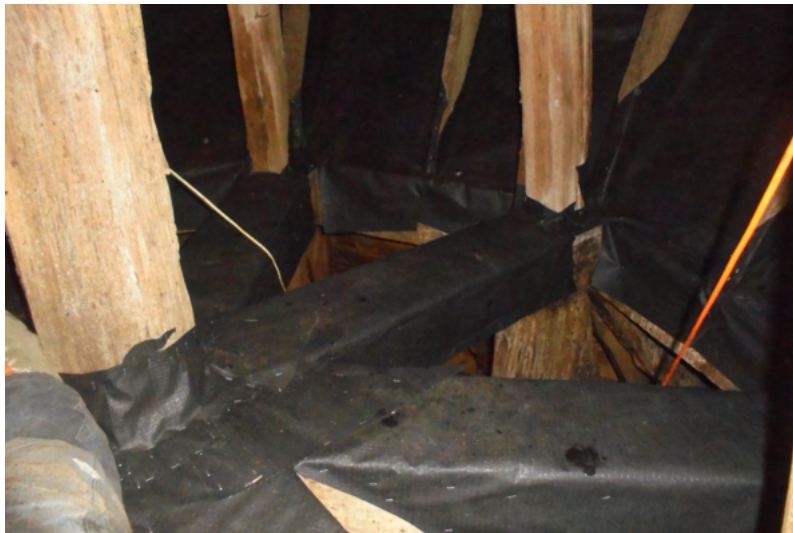
Fig. 6.11: *In the highest level of the tower, the beams are covered with DTB foil, and the formwork of the tower's dome in the lower arch is protected in the same way.*

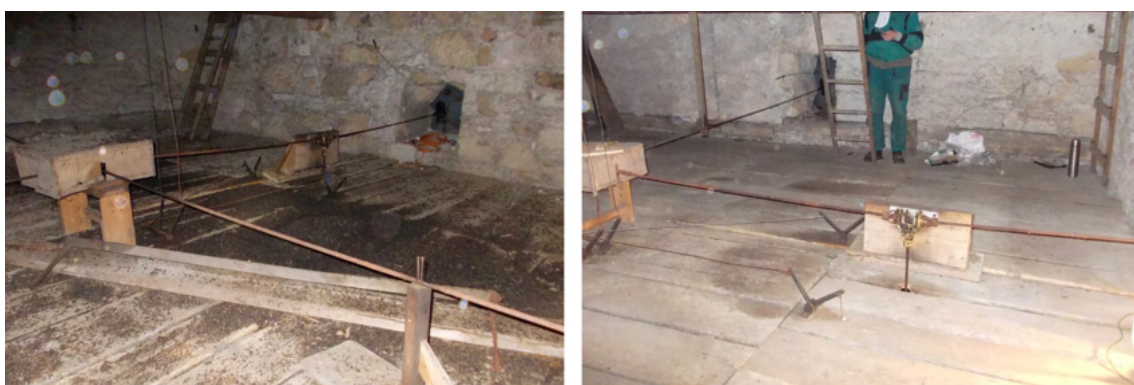
Fig. 6.12: *The lowest level before the cleaning. At first glance, there is a small layer of droppings because the owner cleaned it himself to keep the clock mechanism running (←). Cleaned area of the lowest level — you can see that the space here is narrow. Subsequently, the entire surface was covered with DTB foil (→).*

**( LIBUŇ; CZ )** At the church of St. Martin in Libuň, we dealt with the platform under a colony of the greater mouse-eared bat (*Myotis myotis*) with a size of 450 females. That's a really large size, considering the small space. Guano was on the wooden structures and the clockwork mechanism — causing clocks to stop. The platform shields the clock mechanism and allows the clearing, whereas this structure has four horizontal levels. The lowest is the tower's floor area, which is covered with a vapour-permeable DTB foil and serves as the last catchment area for droppings that fall from higher levels. The second level — about 1.6 m higher — consists of two platforms (yellow on the project drawing) created using OSB panels and boards placed on the tower's trusses. These platforms are covered with linoleum without a raised edge. The third level is only slightly higher (in red on the project drawing) and is made up of a square area inserted between the central vertical beams of the tower. It is also covered with linoleum. The last — the fourth level — is no longer shown in the drawing, but it protects horizontal and inclined beams using DTB foil.

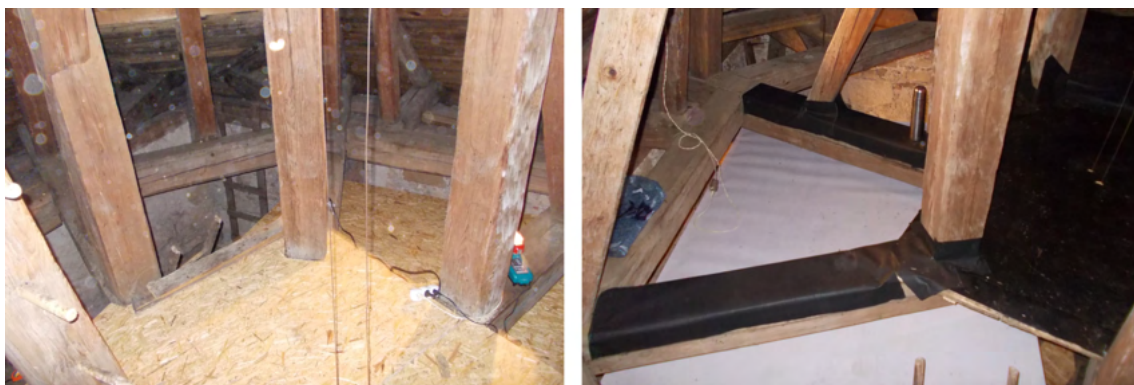
Fig. 6.13: *A view of the installed OSB panels in the second and third levels. The same place, but already covered with linoleum (←). The third level is covered with black, and the second with white linoleum (→).*

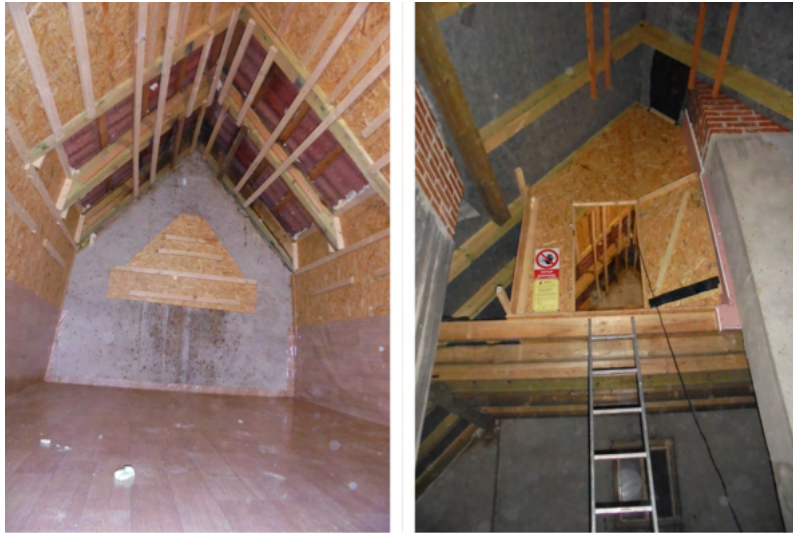
Fig. 6.15: *The shed's interior, where the platform is covered with linoleum — in the upper part, there are battens ready for bats to hang. The rear part is warmer and has exposed roof tiles. In the front part, the shed's ceiling is covered with OSB boards so that air flows behind them — this, together with the chimney wall, cools this part (←). A view of the location of the shed on the stilts in the attic. The inventory opening closes and is secured with a padlock (→).*

The roof consists of shaped ceramic tiles placed on battens. Following the technological procedure, an ordinary vapour-permeable foil was stretched between the battens and the beams. Two hundred female bats (*Myotis myotis*) began to use the space between this foil and the tiles. Their droppings accumulated in this space, which also caused damage to the vapour-permeable foil. As the bats crawled over it, they tore it, and their urine dissolved it. In some places, only remnants of it remained. The residents' requests to use the attic as storage or for drying laundry were incompatible with the presence of bats.

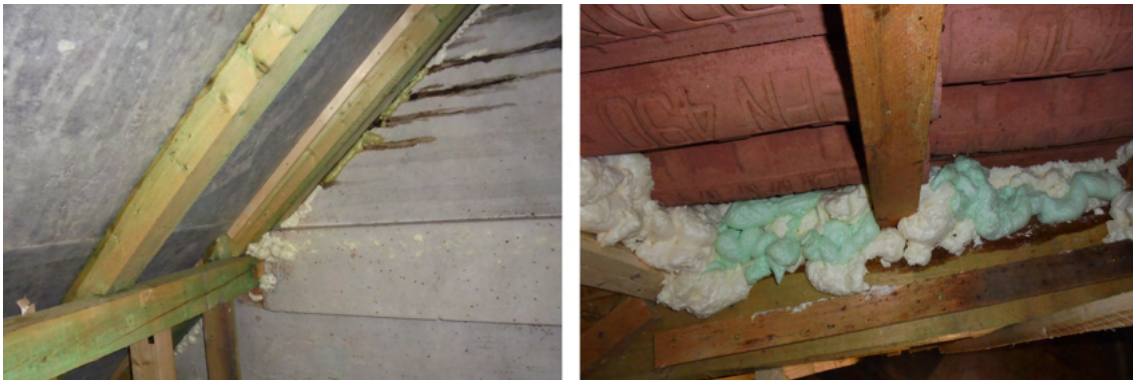
Fig. 6.16: *We sealed all the joints with polyurethane foam, even between the gable and the tiles. In this way, bats cannot get into the attic space under any circumstances.*

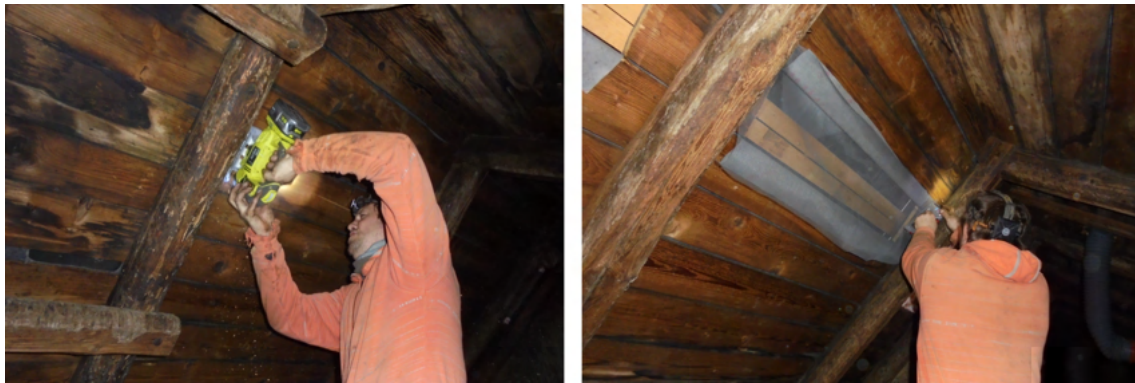
Fig. 6.17: Cutting the original formwork with a jigsaw (←). It was necessary to cut and secure the vapour-permeable foil (→).

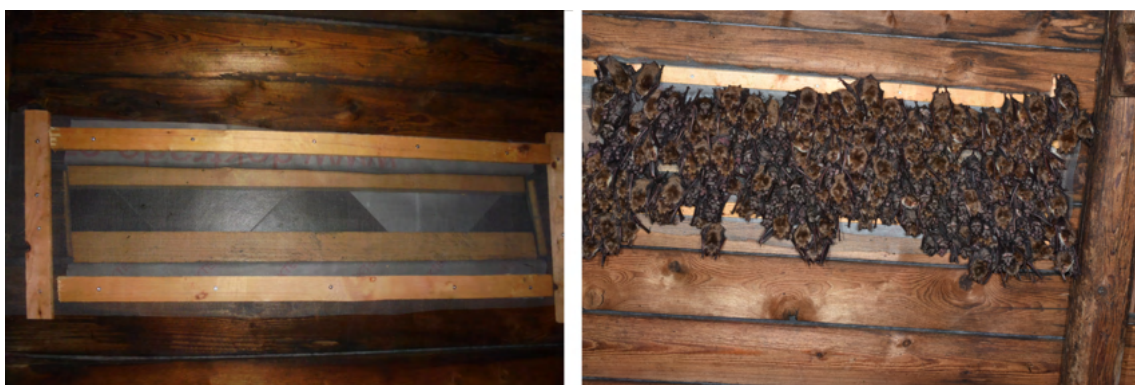
Fig. 6.18: Completed ventilation, where the mosquito net is secured with battens to the original formwork. Already during installation, you could feel the cold flowing air (←). Bats apparently like this measure (→).

Another problem was that the bat guano smelled all over the house. Ventilation and using vapour-permeable foil to divide the space isolated this smell only in the attic space — and significantly reduced its intensity. The biggest problem from the bats' perspective was the roof's reconstruction. The original light asbestos roofing was replaced with a new black one. At the same time, the structure was changed to a ventilated roof, but ventilation of the attic space under the ridge was not ensured. Thanks to this, the attic space was overheated. For the bat colony not to disappear, it was necessary to ensure ventilation of the upper part.

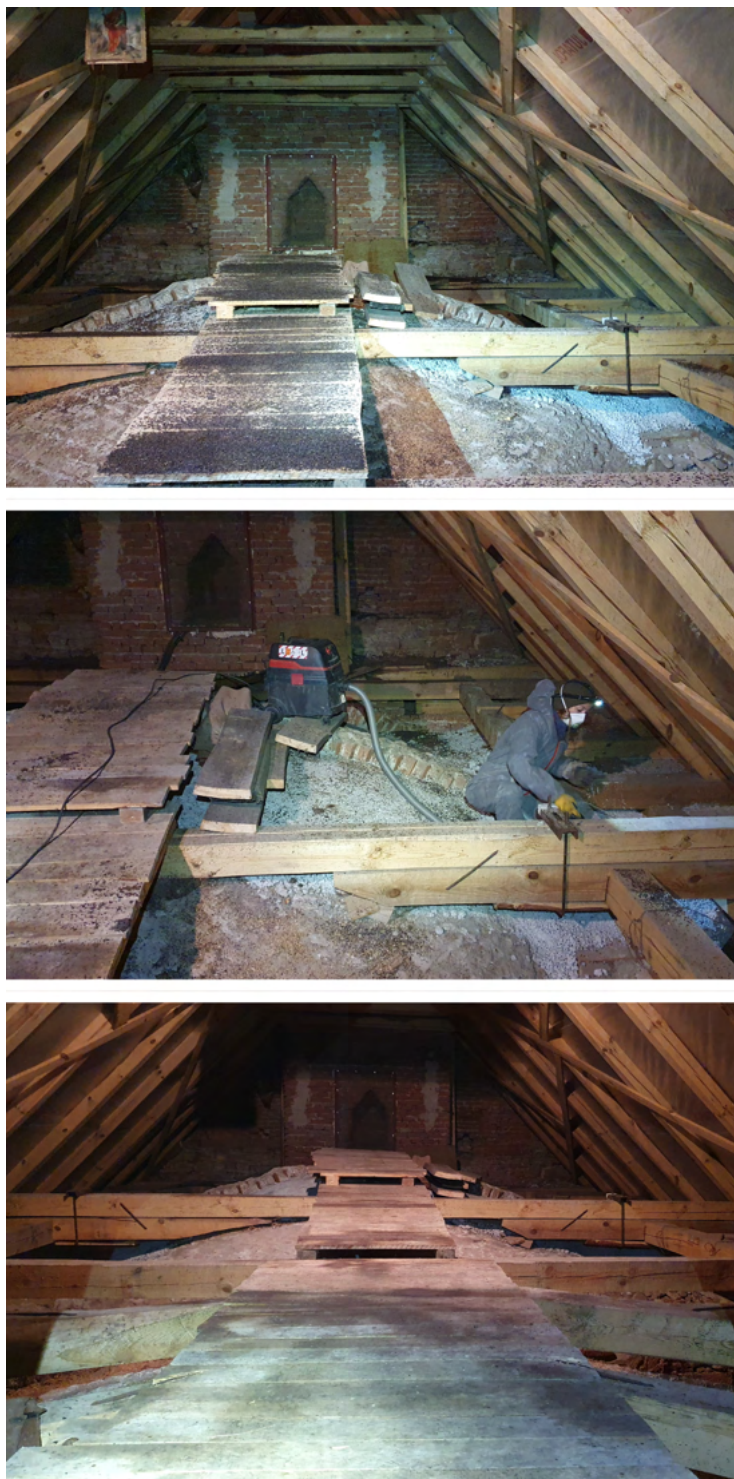
Fig. 6.19: The footbridge and its surroundings are polluted by guano (↑). An industrial vacuum cleaner is a practical tool for cleaning lightly soiled spaces (centre). The resulting state after cleaning the attic and vacuuming the footbridge (↓).

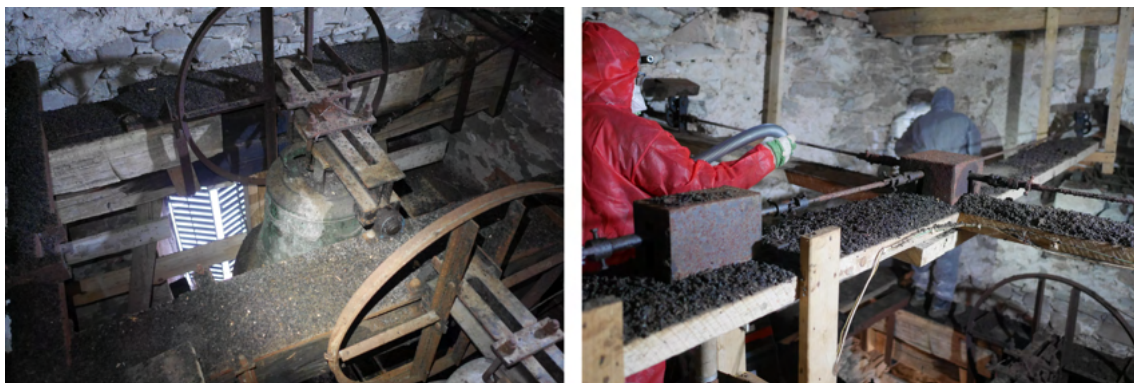
Fig. 6.20: *Original condition — guano pollution is severe and damages the wooden structures and the mechanism of the bells.*

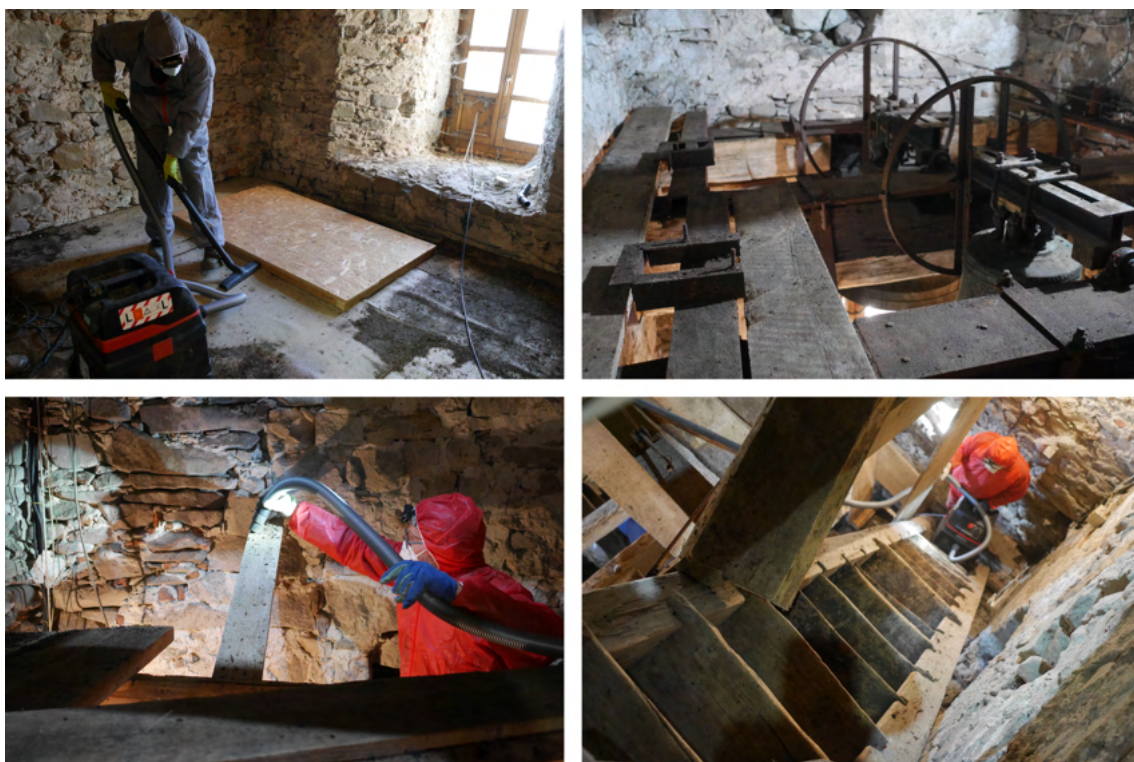
Fig. 6.21: *Thorough cleaning with an industrial vacuum cleaner.*

**( LAŽANY; SK )** The attic of the Roman Catholic Church of St. Imricha in the village of Lažany is only minimally polluted after years without cleaning. In the summer months, there is a colony of the lesser horseshoe bat (*R. hipposideros*) and the Geoffroy's bat (*M. emarginatus*). In the centre of the attic is a footbridge made of massive prisms and boards. When cleaning this space, an industrial vacuum cleaner has proven to be the best and does its job precisely.

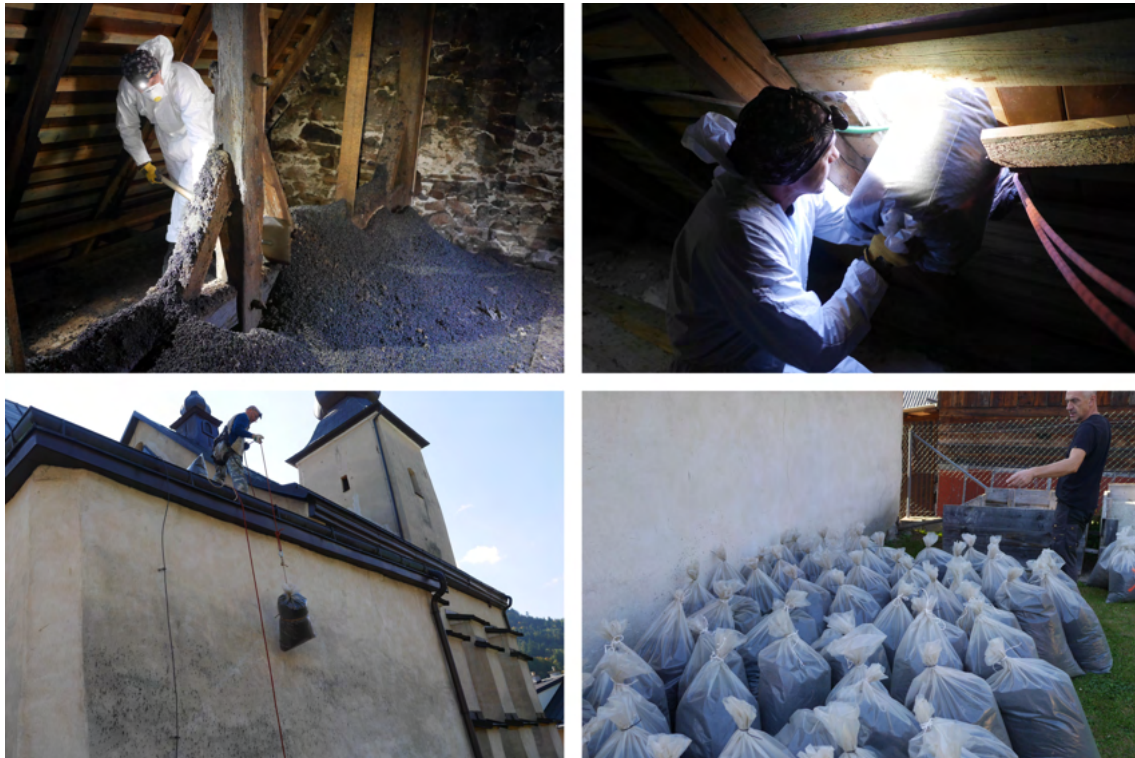
Fig. 6.22: *Transport of bags filled with guano using a rope.*

( **LESNICA; SK** ) In huge attic spaces with numerous colonies of the greater mouse-eared bat (*M. myotis*) it is essential to look for ways to clean and remove guano-filled bags easier. In the Roman Catholic Church of St. Michal Archangel, we unloaded bags through the skylight and lowered them down the rope. There was no lack of thorough safety assurance of the worker who performed this activity. In 2012, the Interreg PL-SK international project was implemented here. The most important modernization and renovation works were carried out on the building, and large platforms were built in the church's attic to collect droppings. Walkways made of solid boards also ensured easy access to the platforms and made it easier to carry bags from the entire attic to the roof skylight. Finally, the footbridges were vacuumed with an industrial vacuum cleaner. This way, it was possible to remove 76 bags from the attic — i.e. approximately 1.5 tons of guano.

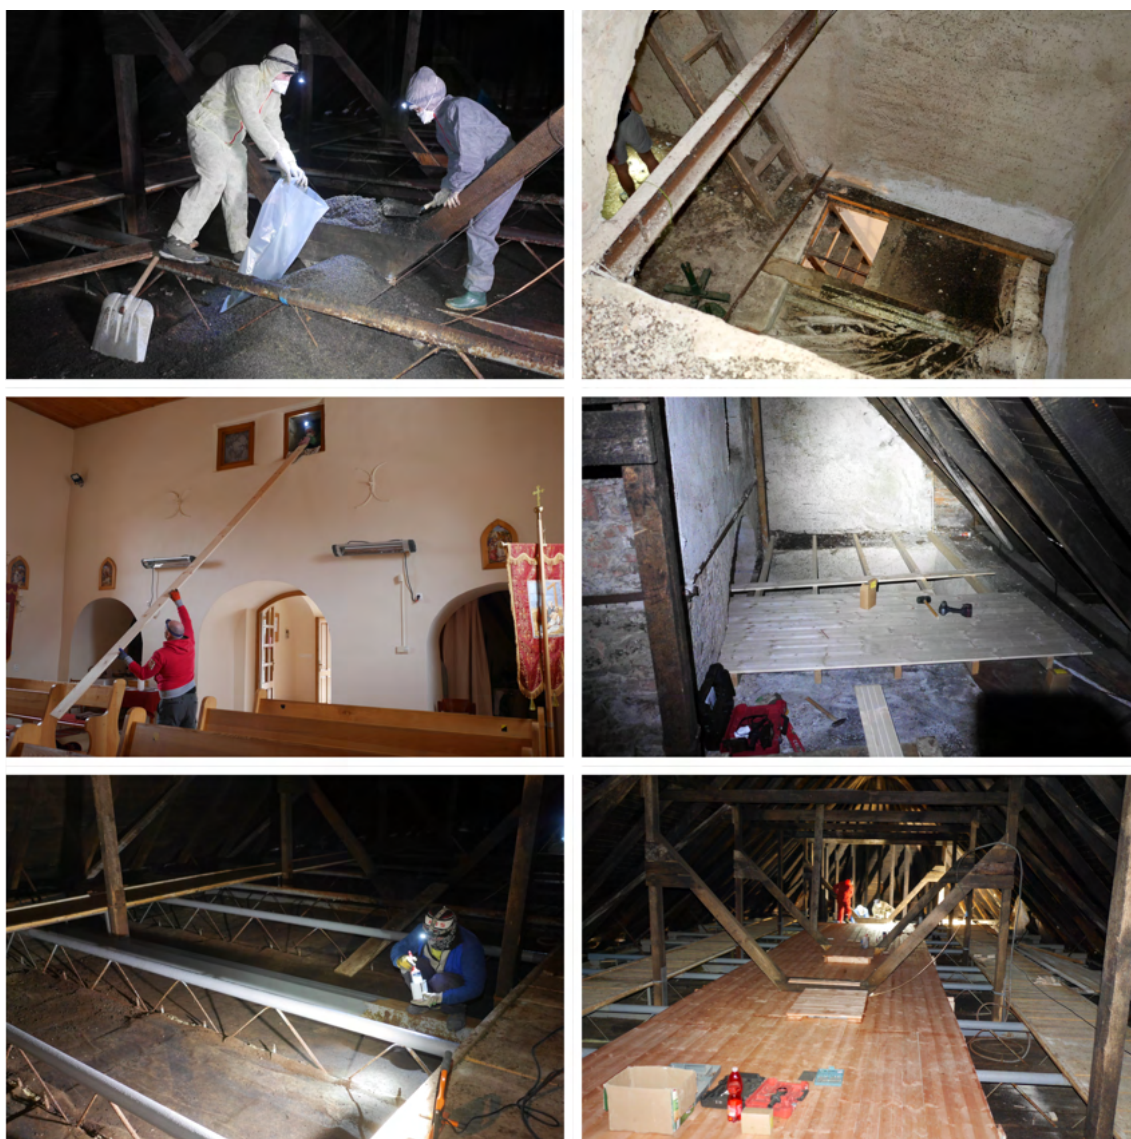
Fig. 6.23: *The original condition of the attic. The foil in the background was originally used to catch guano. However, it prevented the necessary air circulation. Also, condensation caused wetting of the insulation. It was removed and replaced with a platform. Construction material were transported into the tower through a small window. The rusting structures were cleaned with wire brushes and treated with anti-corrosion paint. Above the entrance to the tower, a platform made of spruce boards with an area of more than 70 m<sup>2</sup> was installed. It includes two service holes.*

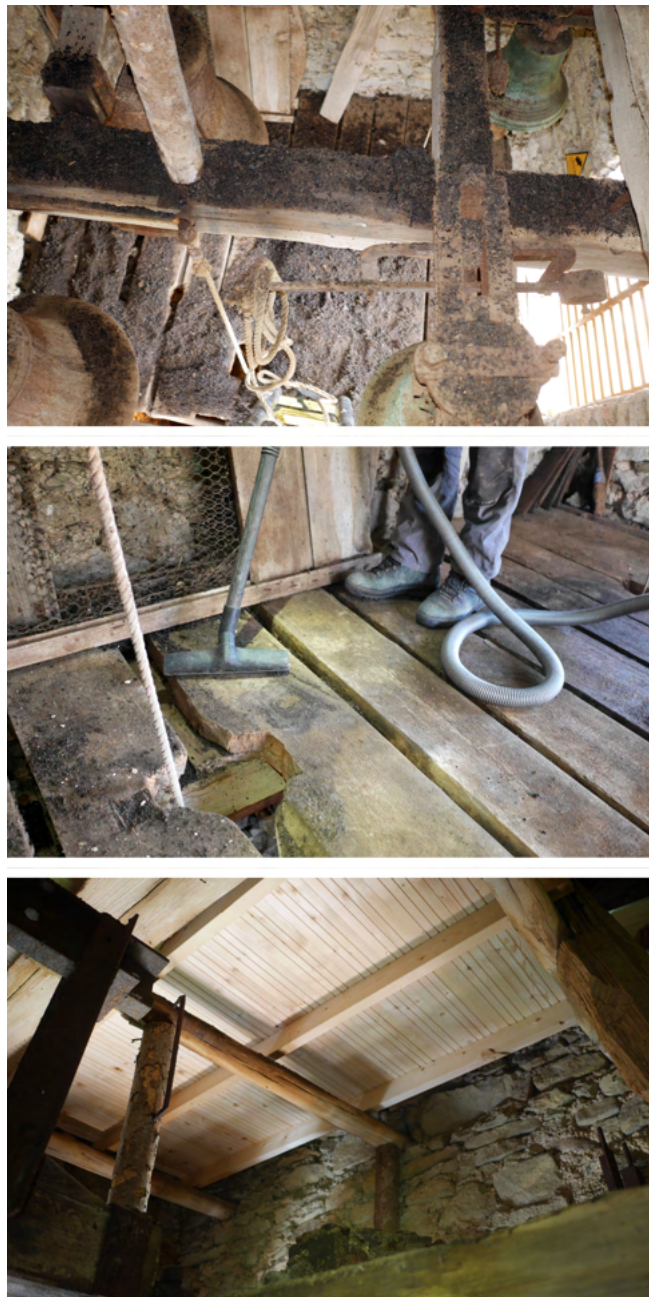
Fig. 6.24: The original state of the church tower contaminated by guano (↑). Cleaning the space under the platform and the bells with an industrial vacuum cleaner (centre). A platform for trapping guano was built above the bell structure (↓).

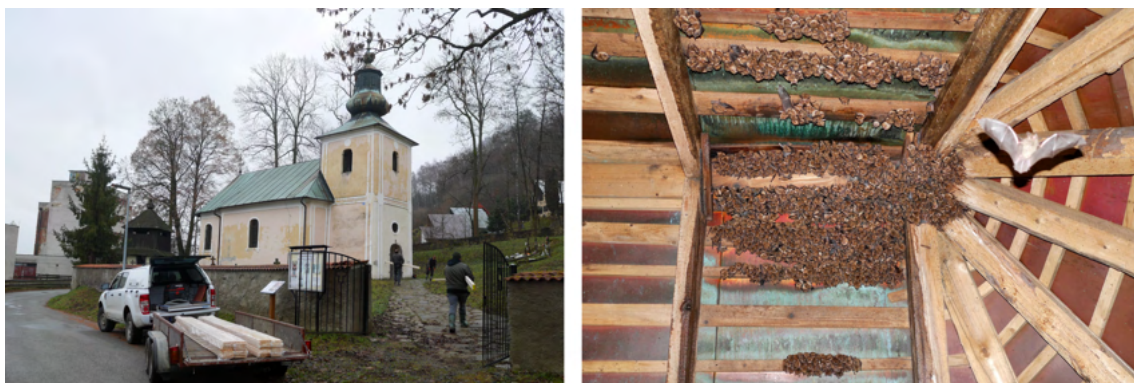
Fig. 6.25: Transport of material for the platform construction (←). Maternal colony of Geoffroy's bats (*M. emarginatus*) in the attic of the church (→).

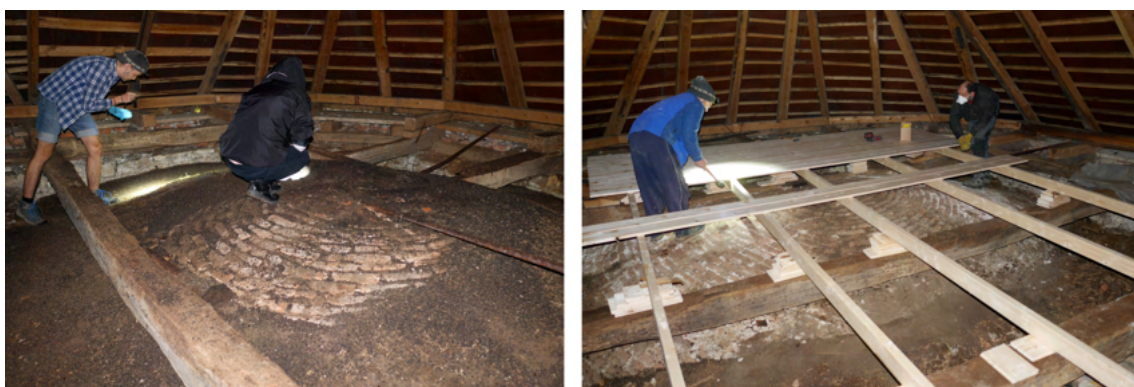
Fig. 6.26: The original contamination of the vault and its surroundings by guano (←). Foundation of the platform and adjusting its height above the vault (→).

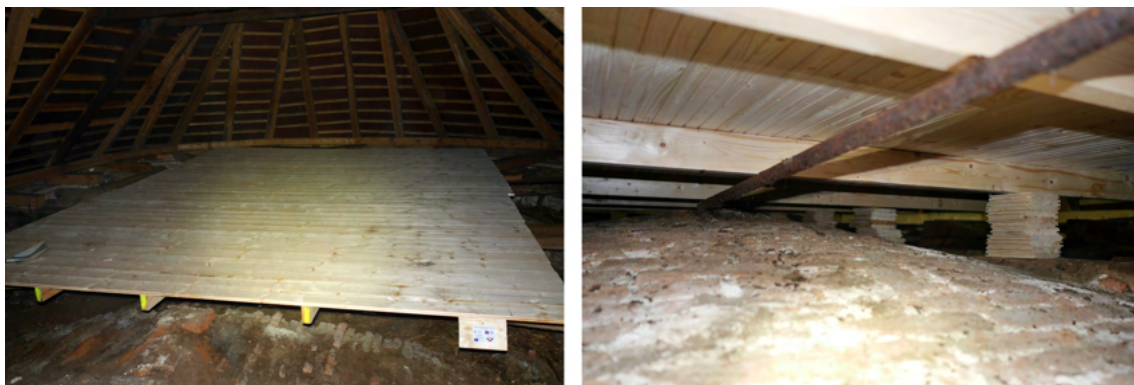
Fig. 6.27: The finally assembled platform in the back part of the attic - the place where the colony of bats gathers (←). Underpinning the prisms with columns from board scraps (→).

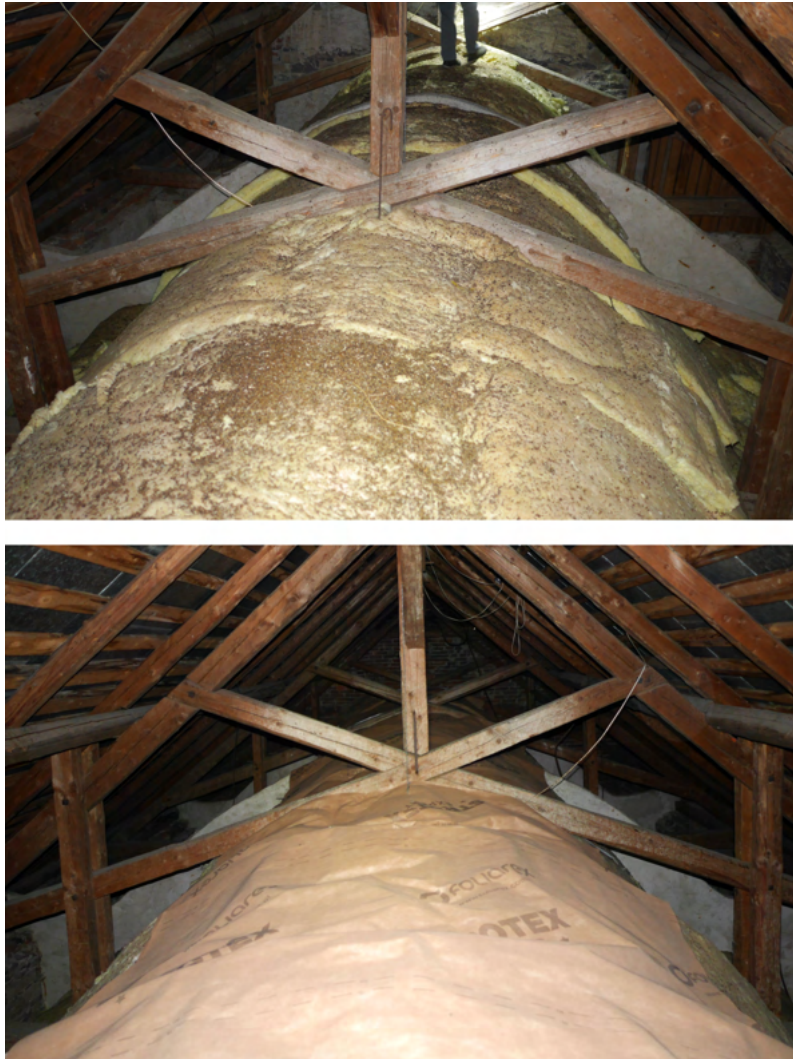
Fig. 6.29: *Insulation contaminated by guano. Cleaning such surface is practically impossible (↑). A loosely laid vapour-permeable foil that separates the falling guano from the insulation and facilitates cleaning in the future (↓).*

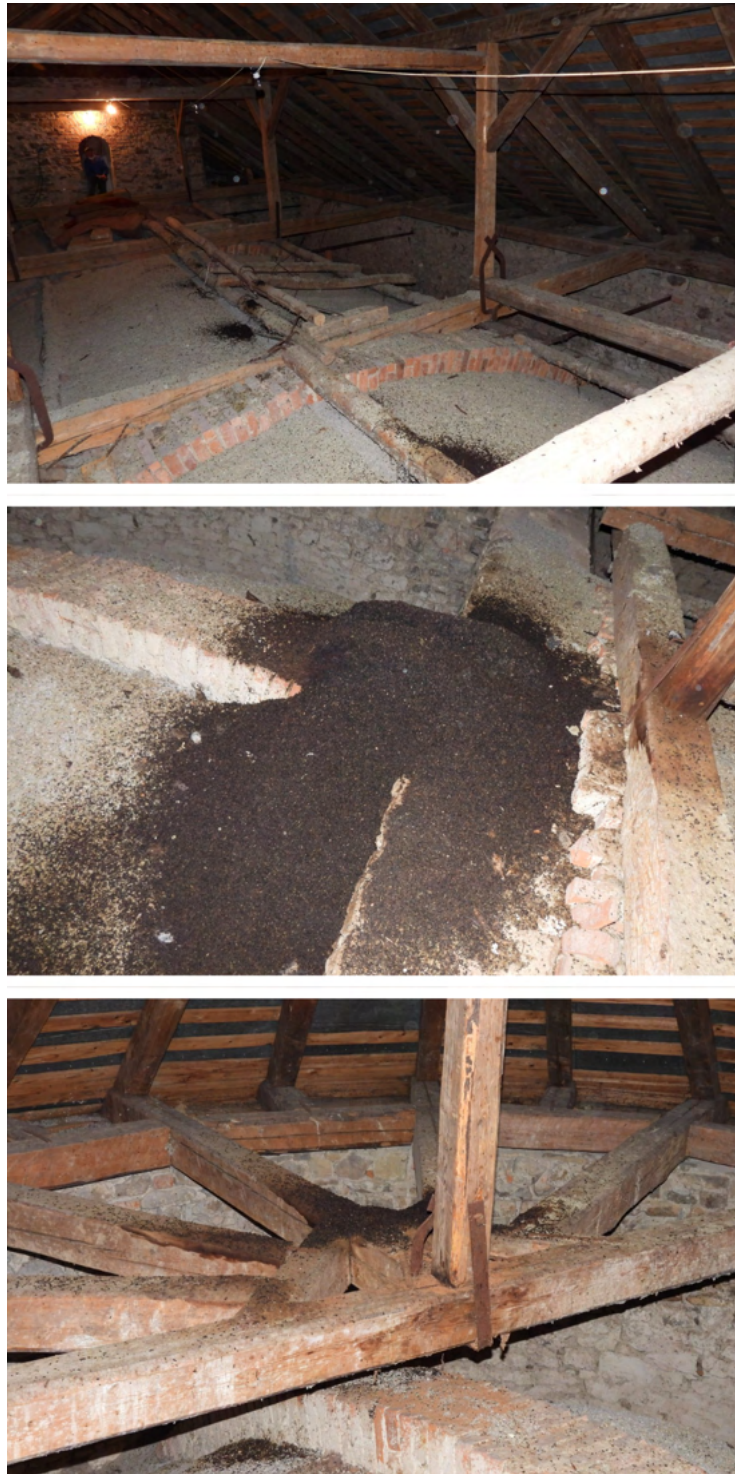
Fig. 6.30: Insulation contaminated by guano. Cleaning such space is practically impossible.

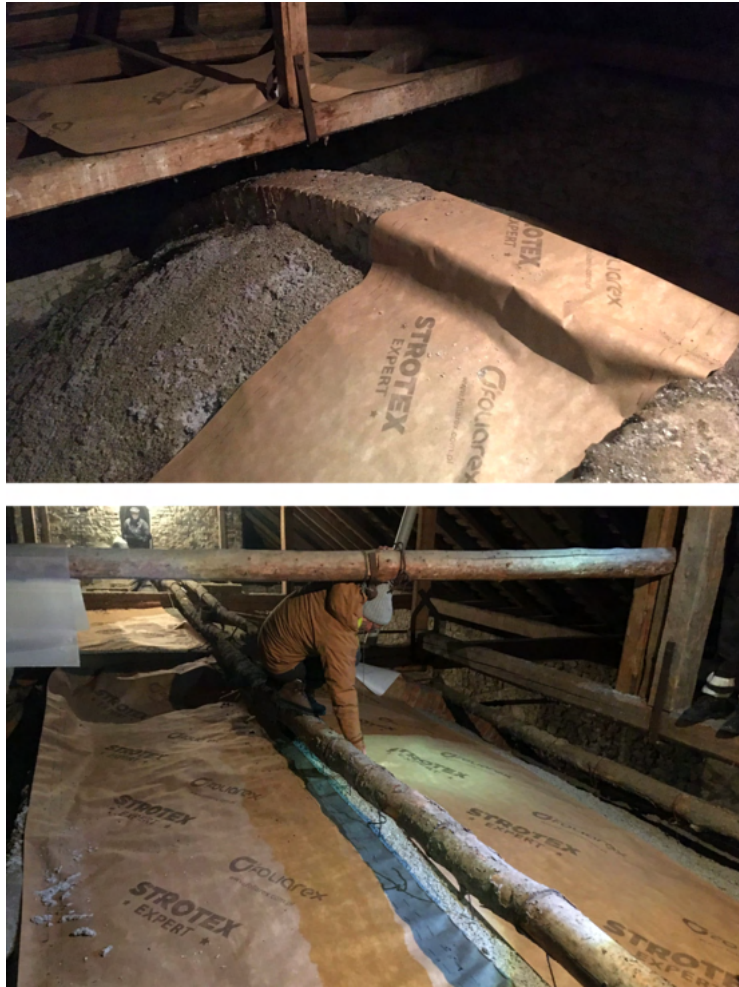
Fig. 6.31: *Covering blown-in insulation with a vapour-permeable foil - separates the falling guano and enables cleaning.*

**( PRIEKOPA; SK )** In the summer months, the attic of the Greek Catholic Church of the Nativity of the Blessed Virgin in the village of Priekopa is inhabited by smaller colonies of two species of bats - the grey long-eared bat (*Plecotus austriacus*) and the serotine bat (*Eptesicus serotinus*). Contamination with droppings is not significant, but mineral wool insulation is laid on the vault along the entire attic, making it impossible to vacuum. In 2022, we put a vapour-permeable foil over the insulation, separating the falling guano from the insulation and making cleaning easier. The droppings on the surface of the foil dries effectively and can be easily swept or vacuumed.

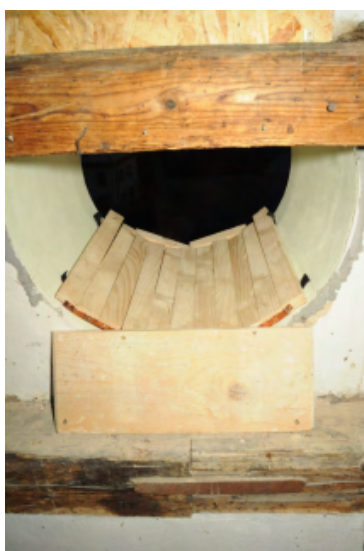
Fig. 6.32: *Wooden slatted grate in the circular window.*

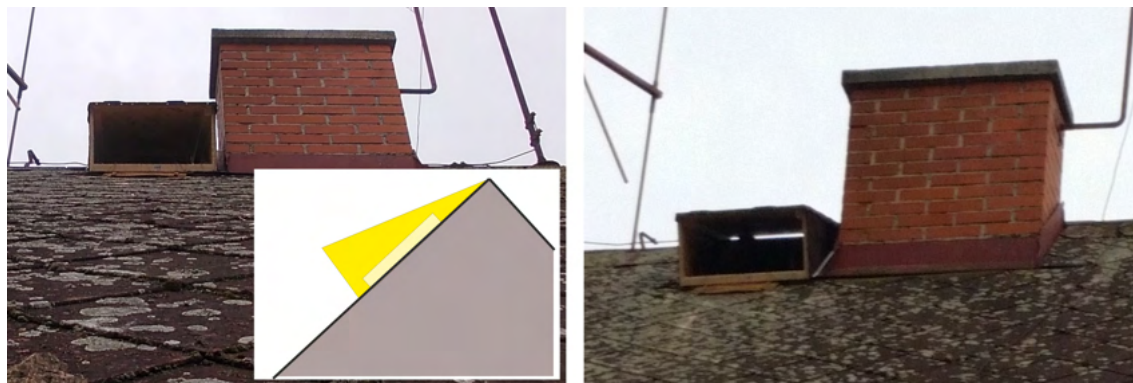
Fig. 6.34: A hinged dormer allows bats access to the attic.

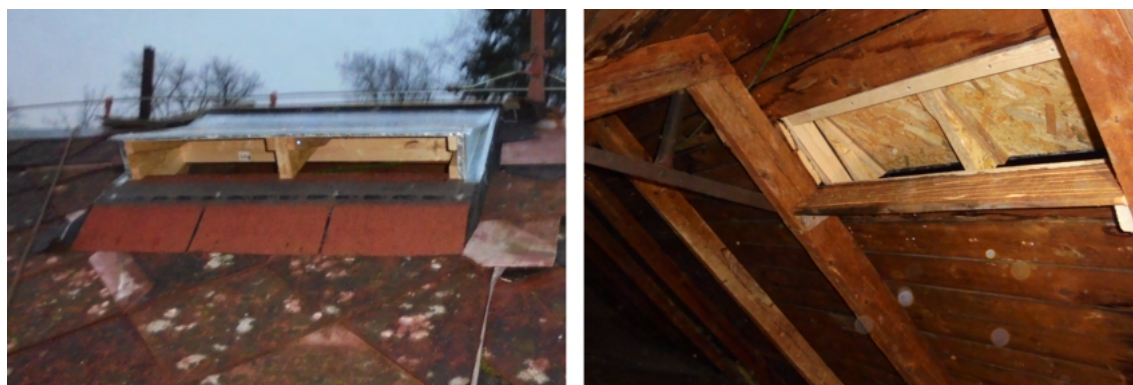
Fig. 6.35: A dormer as a replacement for a missing flight entrance.

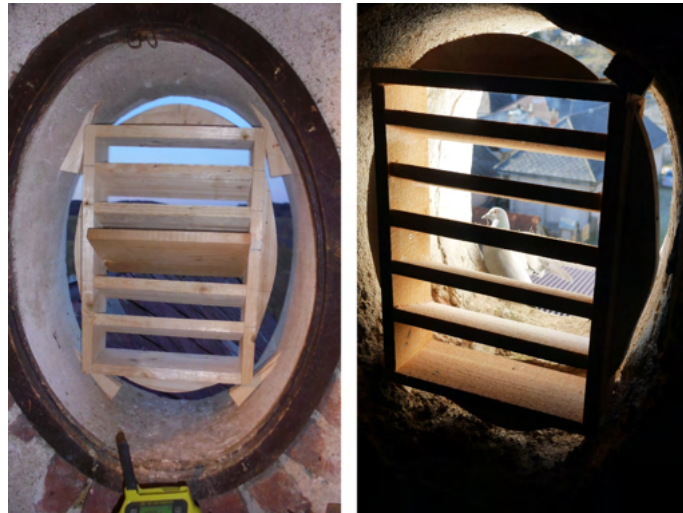
Fig. 6.36: *Insert blinds from unplanned boards. The same solution, which effectively prevented pigeons from flying in, was implemented in the attic of the church in the village of Rožňavské Bystré (SK; →).*

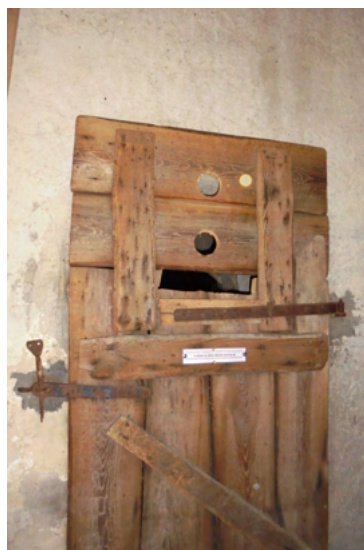
Fig. 6.37: *Flight entrances placed in the door.*

( **BĚLÁ POD BEZDĚZEM; CZ** ) The flight entrance does not have to be the only access to the attic from the outside. In this case, bats enter the church through the louvred windows in the tower and climb into the attic along the door. This door connects the space in the tower with the attic. For easier access, we created two circular and one rectangular opening in this door with a bat. This measure was also successful.

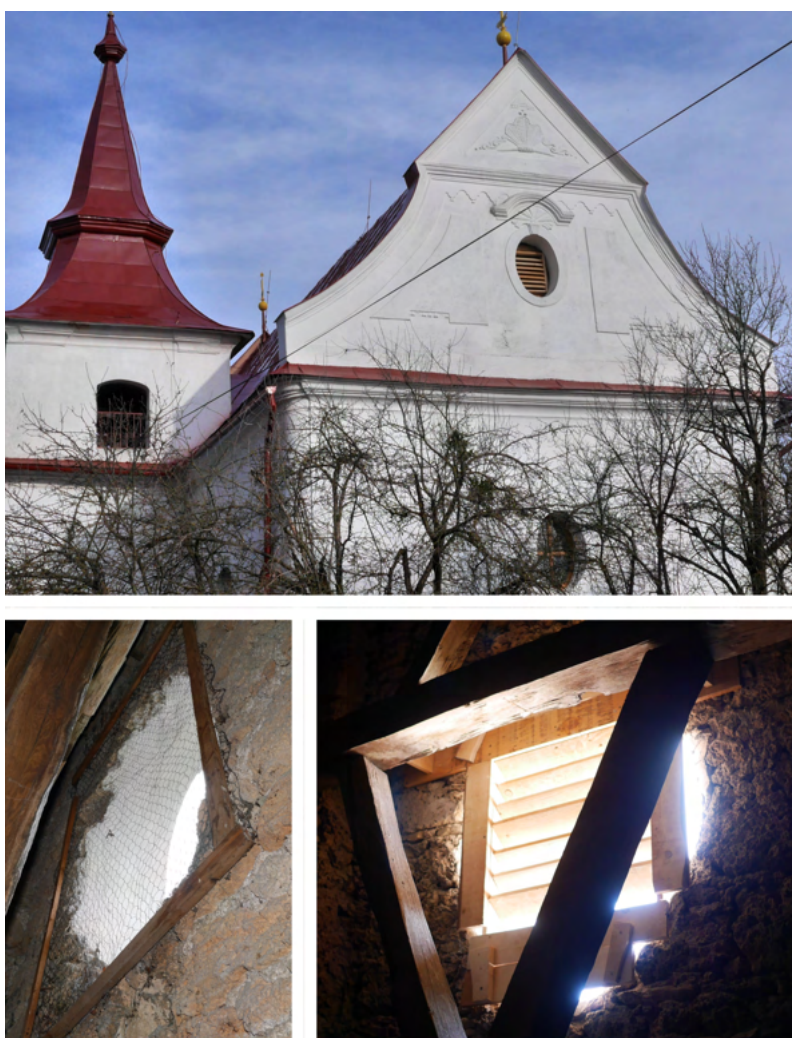
Fig. 6.38: Church in Silická Jablonica (↑). The mesh acted as a trap for bats and caused their deaths (←). Wide blinds made of unplanned wooden boards (→).

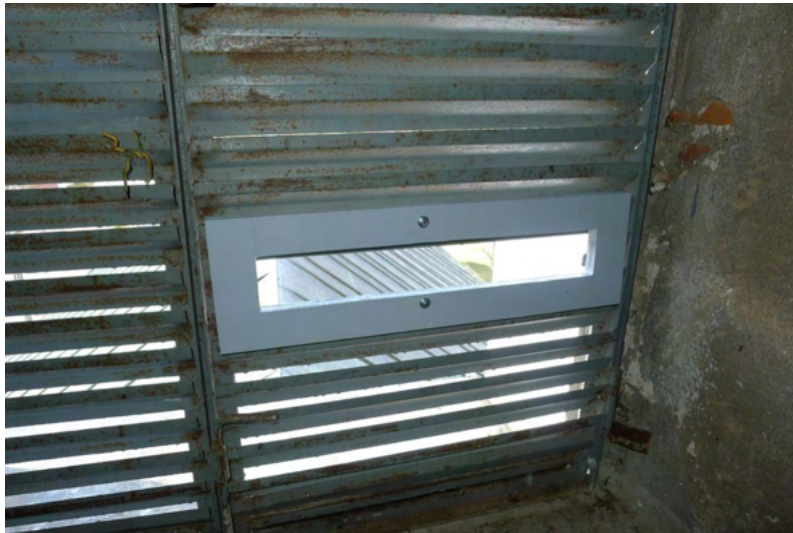
Fig. 6.39: *Flight entrance in metal blinds.*

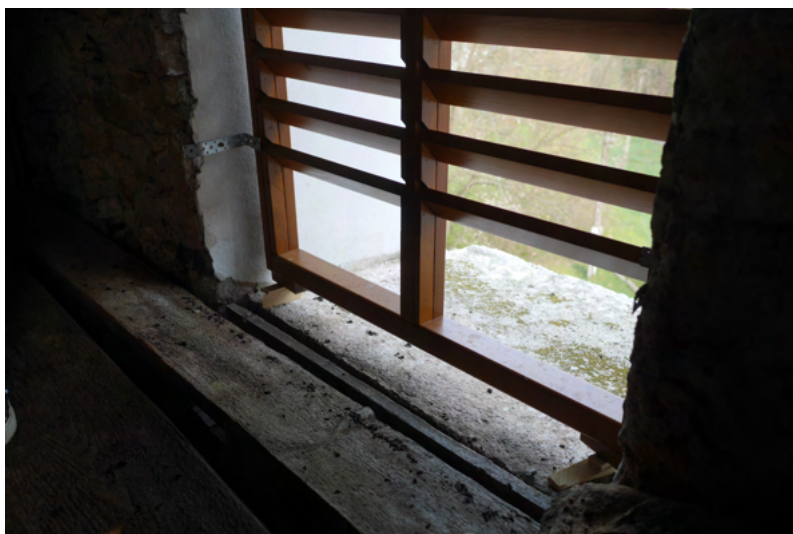
Fig. 6.40: *Flight entrance in new window blinds (planned in advance).*

**( L'UBOVEC; SK )** We can also afford larger flight entrances in a location with no problems with pigeons. The attic and the tower of the Greek Catholic Church of the Nativity of the Virgin Mary in the village of L'ubovec are inhabited by several species of bats - the breeding colony of the greater mouse-eared bat (*M. myotis*), Geoffroy's bat (*M. emarginatus*) and the lesser horseshoe bat (*R. hipposideros*). We chose to create a spacious flight entrance in the new window blinds.

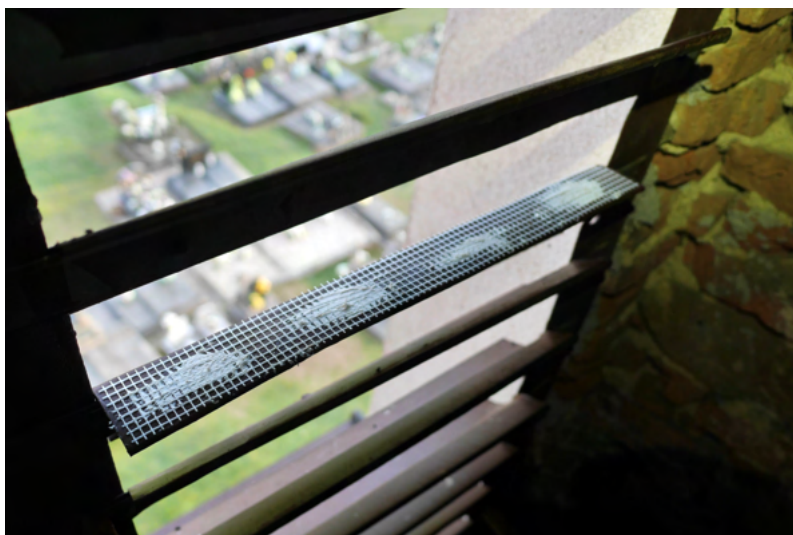
Fig. 6.41: *The fibreglass mesh allows bats to land on the blinds. It is glued with UV-resistant glue.*

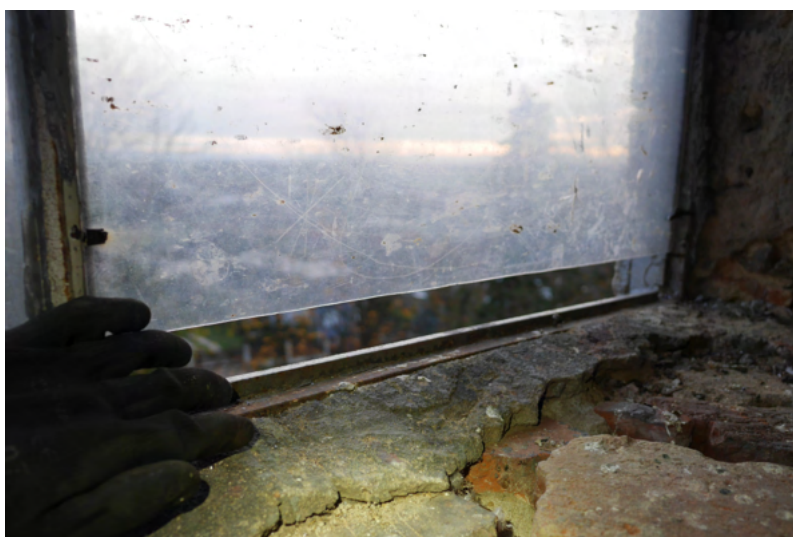
Fig. 6.42: *Flight entrance reduced by plexiglass.*

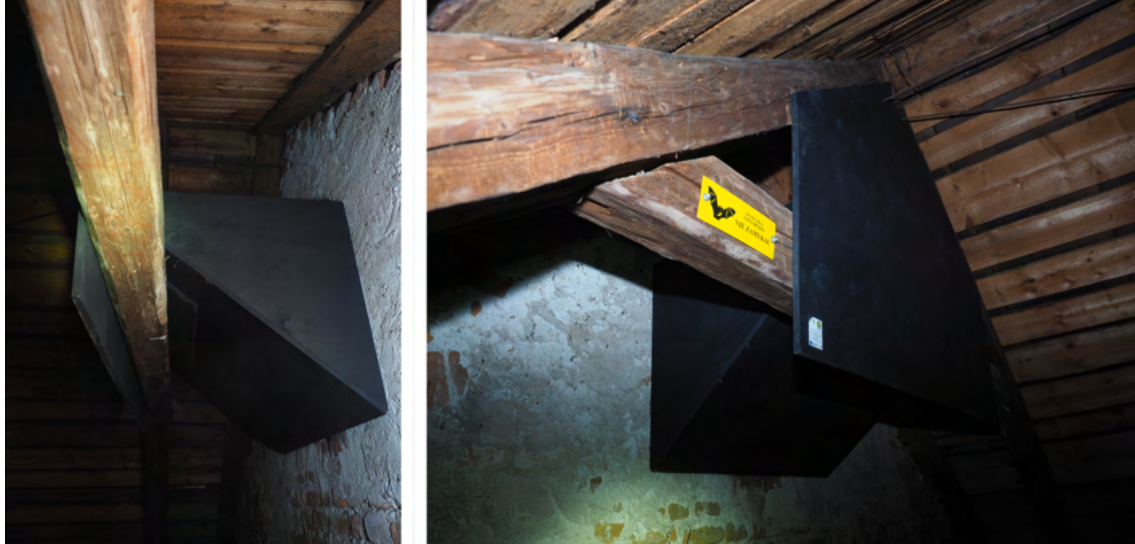
Fig. 6.43: A shelter constructed of wooden boards with a dark coating in the attic of the Cistercian Abbey, including a shading screen for the shelter's interior.

( SZCZYRZYC; PL ) Sunlight and street lights penetrating the bat roost from outside can limit the amount of attic space available to the animals. Therefore, constructing different types of covers for the flight entrances is important for protecting bats in attics. They are used in dozens of locations with the occurrence of lesser horseshoe bats (*R. hipposideros*) in Poland.
