# **Conservation of Bats in Attics**

## **A practical guide**

**BAT4MAN-HUSKROUA/1702/6.1/0021**

PUBLISHED BY **SLOVAK BAT CONSERVATION SOCIETY** © 2022

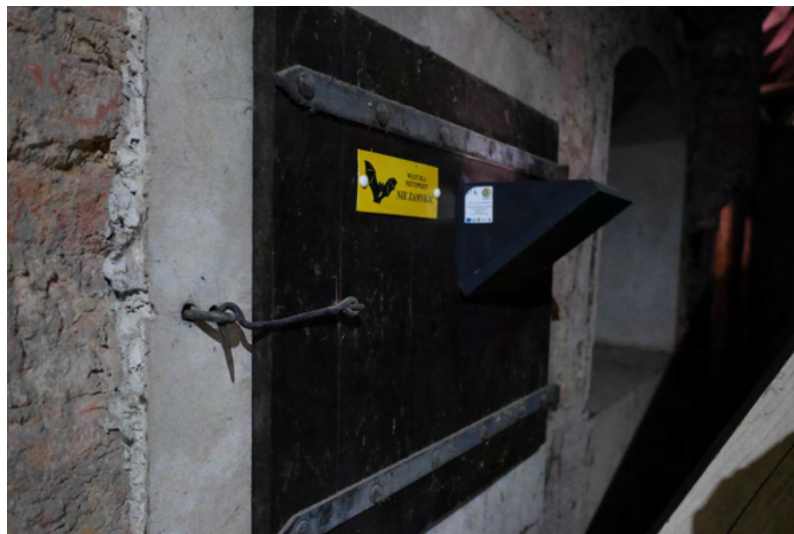
Fig. 6.44: Shade screen on the bat flight entrance. At the same time, the modified flight entrance protects the bat shelter from predators (martens, owls) and prevents pigeons from entering the attic.

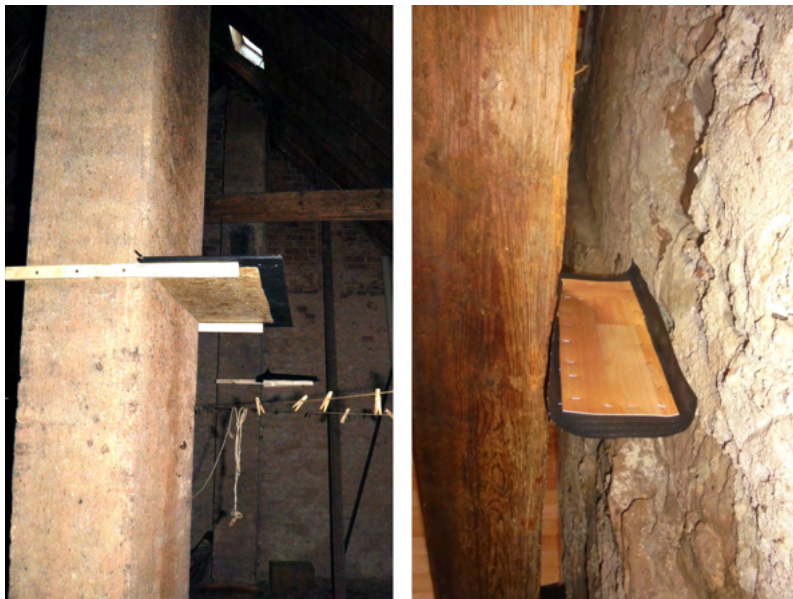
Fig. 6.45: On hot days, bats like to cool off on walls and the walls of chimneys. To reduce the amount of guano on the floor, an OSB panel can be attached to the chimney using laths and dowels (Vysoké Veselí; CZ; ←). If the stand is too close to the wall and it is difficult to clean behind it, we can use an additional board in the place where the gap widens (Horná Police; CZ; →).

**Chimney and wall protection:** Bats' favourite habitats are gable walls and chimneys, where they hang on hot days to cool off. A thicker layer of droppings forms near the bottom of the chimney or the wall. The construction of the platform protects these masonry parts of the building and prevents guano from falling between the wall and the platform itself. The solution is to place a board at an angle and attach it to the platform with a screw — so that the board also creates pressure on the wall. To avoid stains, the lower and upper edges of the board must be placed diagonally, while the edge to the wall must have a sharper angle than the edge to the floor. Connecting two obliquely placed surfaces where difficult-to-measure angles are formed is difficult. In this case, we recommend planning the side edges as well — the boards then go together more easily. If there is a leak between the wall and the board (for example, due to uneven masonry), it is possible to fill the joint with transparent silicone — it solves the problem very quickly and elegantly. If there is less guano somewhere, it is possible to supplement the chimney or the wall near the platform's edge, for example, with a sealing PVC strip intended primarily for the edges of the kitchen countertop.

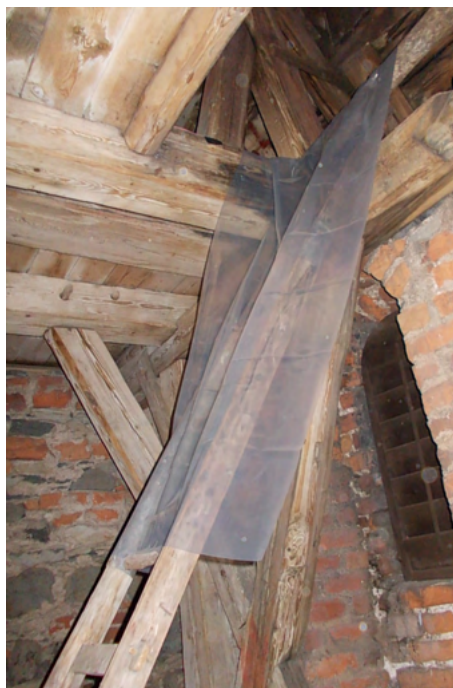
Fig. 6.46: This plastic strip is not installed to trap guano — it has a different purpose. The site had a problem with martens that kill bats. However, the martens could only get to the bats using a ladder. The slippery 1.5-meter-long plastic is an insurmountable obstacle for any marten (Frýdlant; CZ).

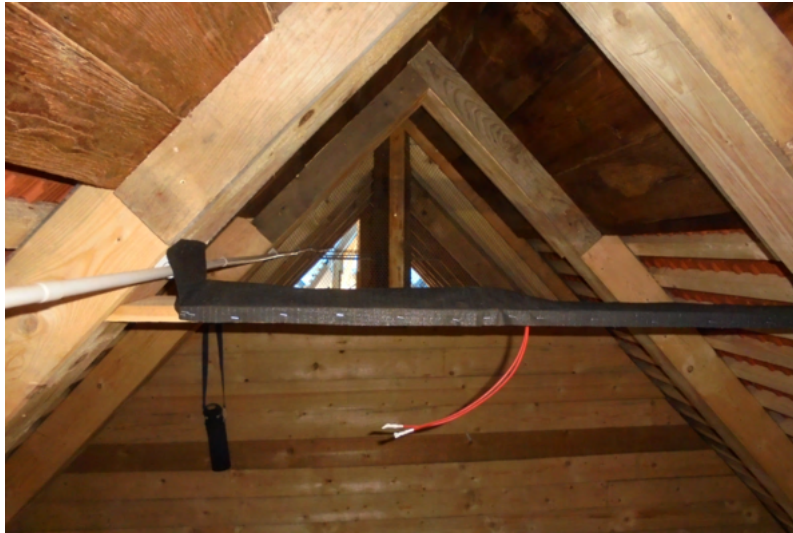
Fig. 6.47: *Electrical installation, fire detectors — if installed under bats, they are very difficult to clean. It is, therefore, advisable to cover them with DTB foil (Horná Police; CZ).*

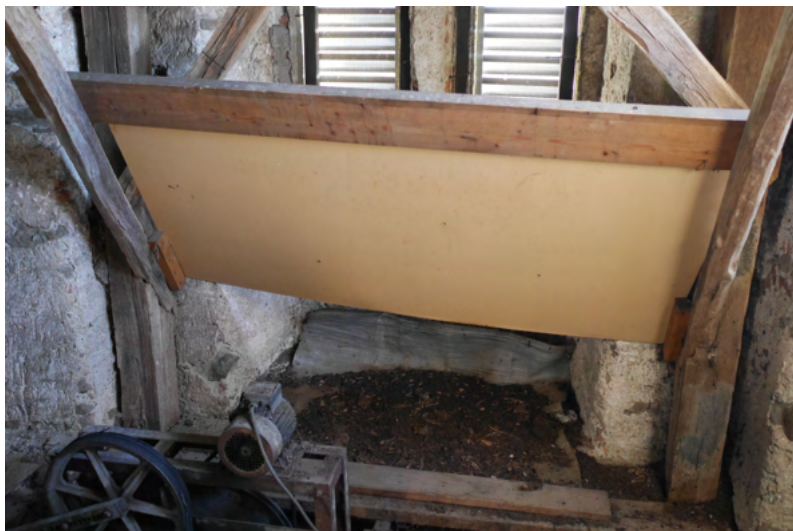
Fig. 6.48: *For smaller colonies or in small tower spaces, it is sufficient to divert the impact of droppings. In this case, bat guano falls from a hole in the vault in the church tower onto the floor where the bell mechanism is located. The board is used to deflect the impact of droppings away from these structures - concentrated droppings in this way can be removed more easily (Vyšná Kamenica; SK).*

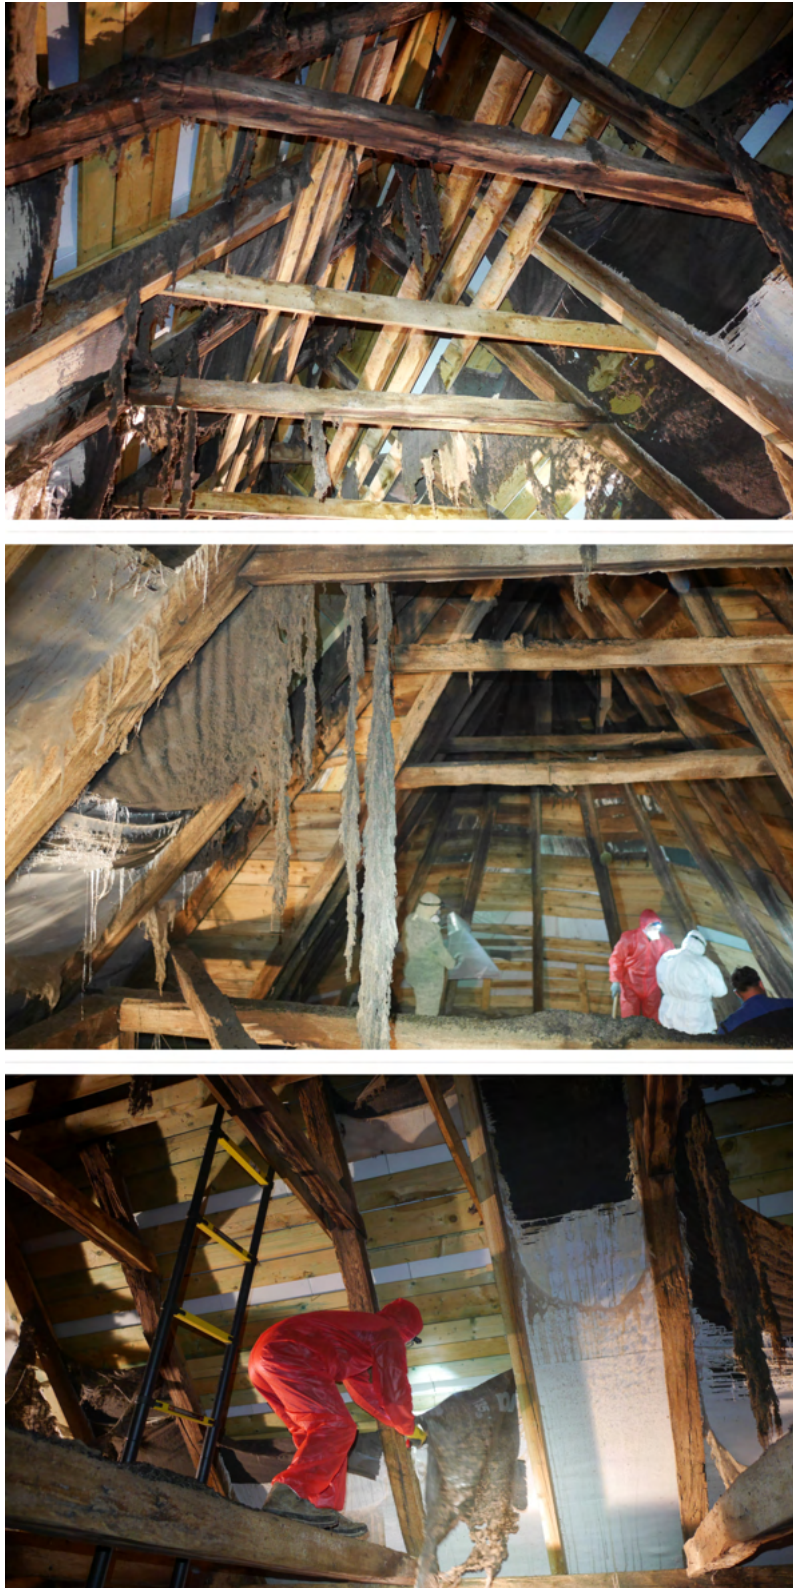
Fig. 6.49: Large bat colonies negatively affect attics, where the vapour-permeable foil is stretched under the roofing. At the same time, they pose a significant risk for bats - they tear them unintentionally with their claws and get caught in the damaged foil. Especially the young ones, they often get entirely entangled and die. This is an example of severe damage to foils in the attic of a church by a colony of the greater mouse-eared bat, the size of 2500 females. Damaged foils had to be removed (Sačurov; SK).

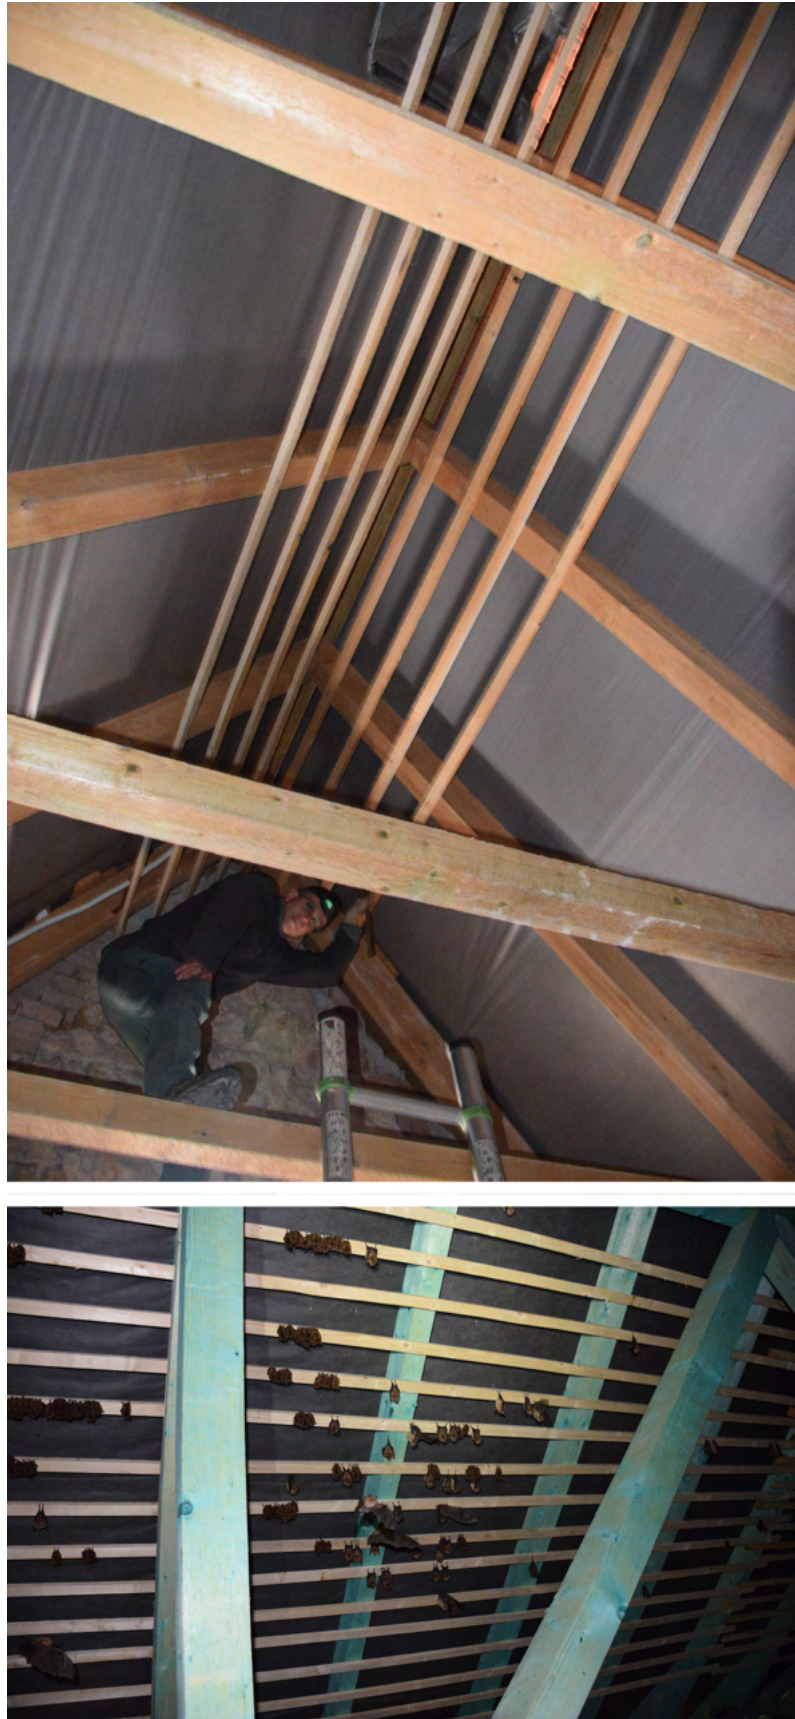
Fig. 6.50: The habitat choice of bats in the attic can also be guided by the additional construction of elements for holding and hanging individuals. In this case, it involved the installation of battens from the underside of the rafters so that bats do not damage the vapour-permeable foils. This measure can be efficient and effective, for example, in colonies of lesser horseshoe bats.

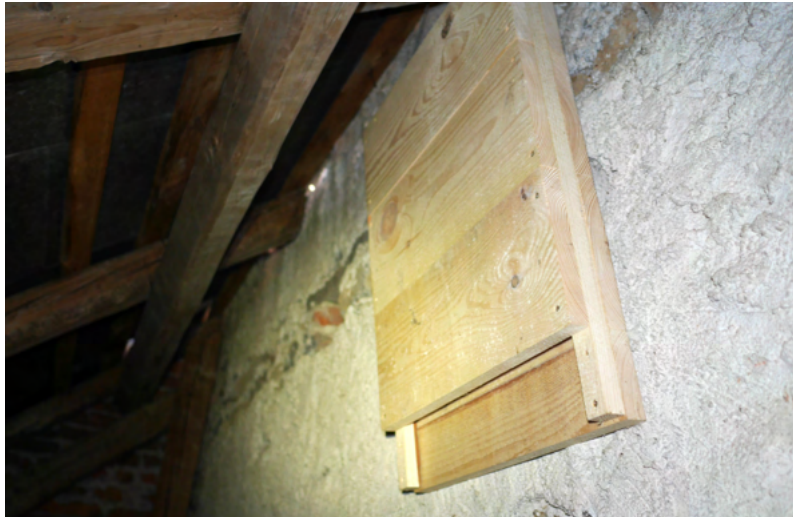
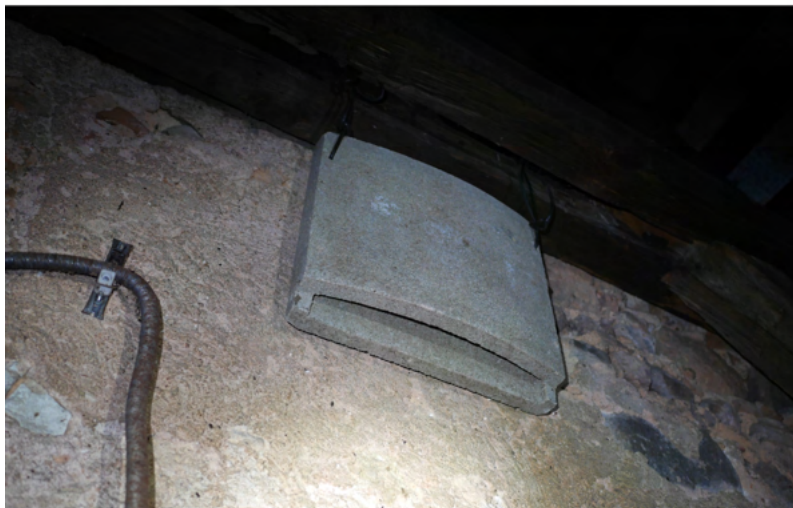
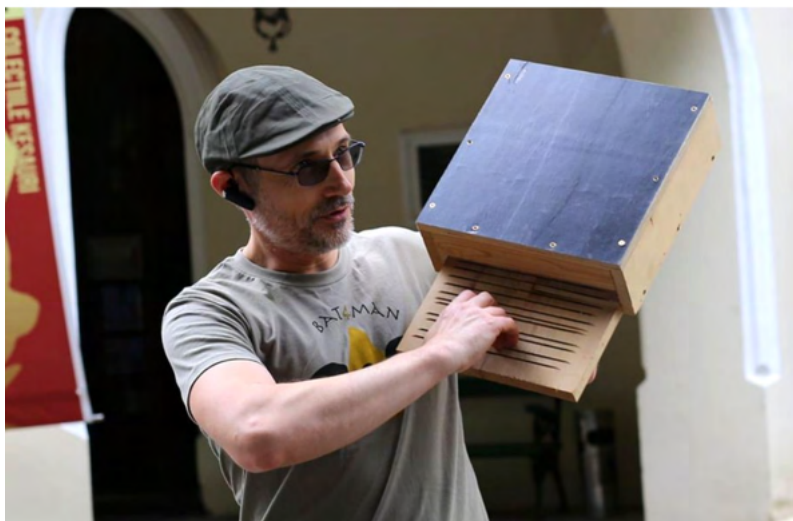
Fig. 6.51: *Improving the shelter for bats can also consist in hanging the boxes in the attic. Wood-concrete boxes or boxes made of unplanned boards will provide a stable shelter for crevice bat species, in which the individuals will feel safe from predators.*

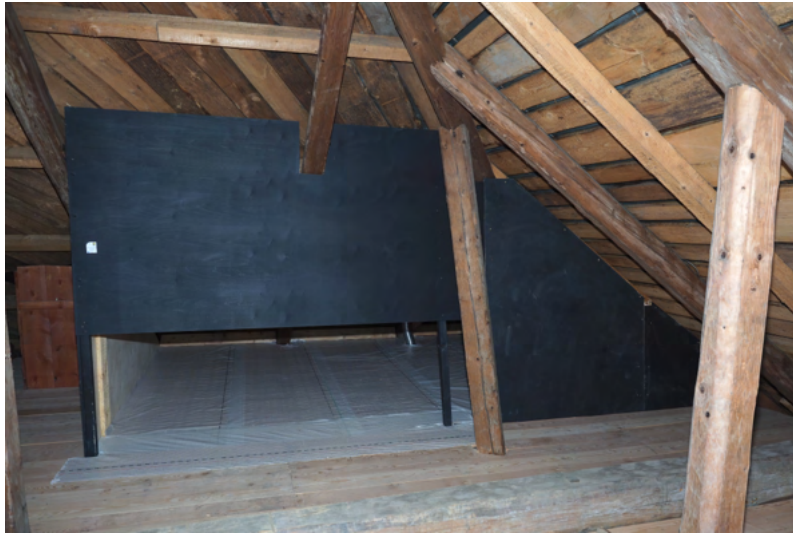
Fig. 6.52: One type of micro shelter in the attic of the abbey is in the form of a small built-in space in a large attic. The floor is protected from guano by vapour-permeable foil (Szczyrzyc; PL).

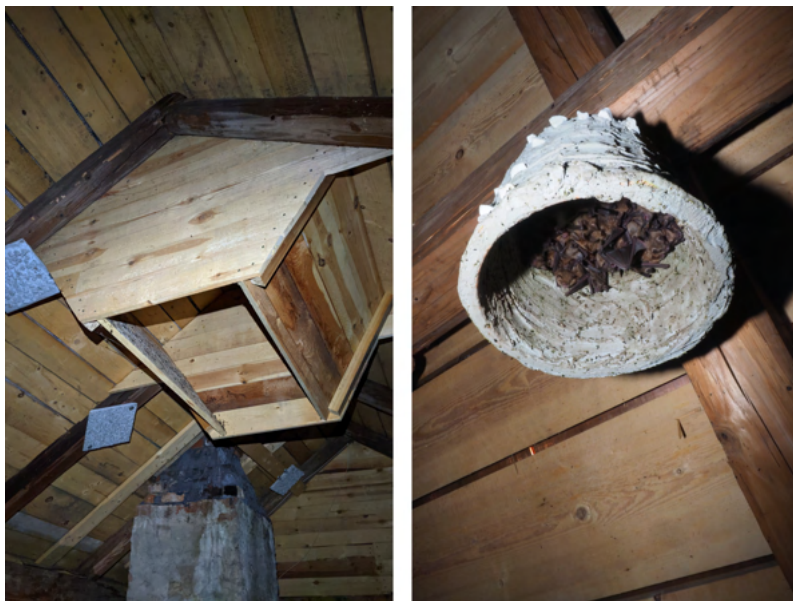
Fig. 6.53: Another type of micro shelter installed in a former primary school is a built-up space in the roof's gable that ensures a stable microclimate and darkness in a large and well-lit attic space (←; Wojkova; PL). A micro-shelter "chandelier" in the attic of the church is made of a ceramic pot, which is especially popular with the Geoffroy's bat (→; Jaworzna; PL).

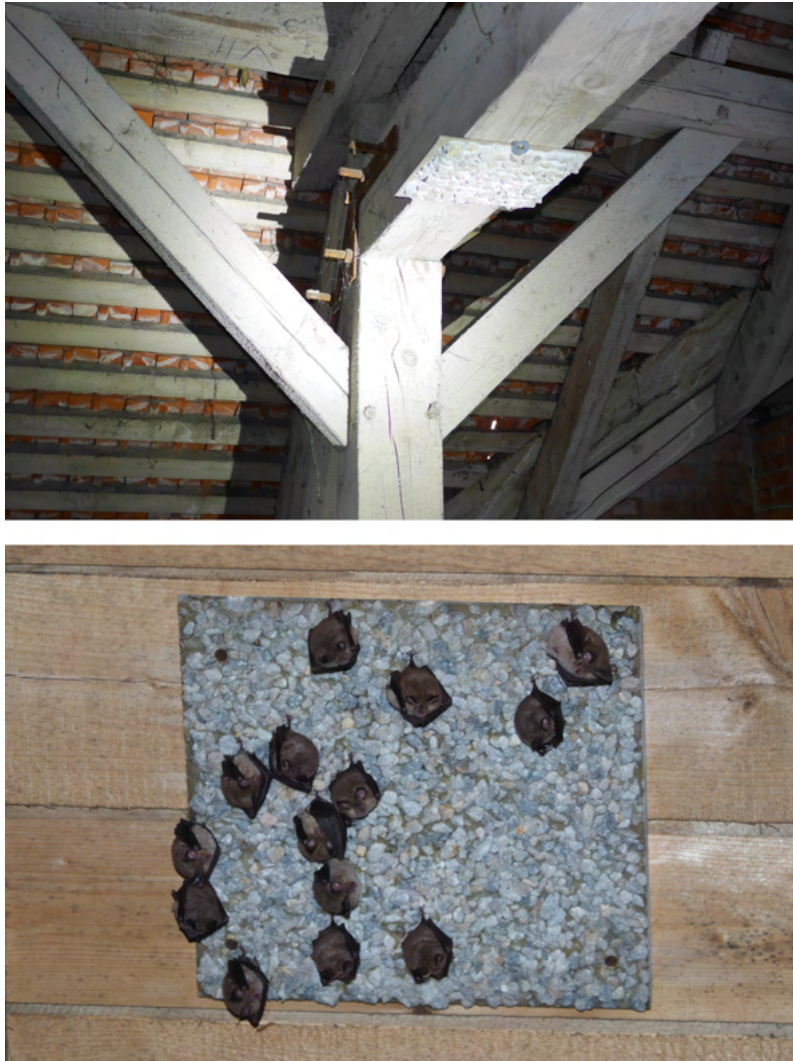
Fig. 6.54: *Microshelter - stone tile located in the building of the marble factory, specially designed for the lesser horseshoe bat. It is suitable for installation horizontally or on the inside of roofs - or in other micro-locations (Szczyrzyc; PL).*
